Access Compliance Report Public Rights-of-Way (Curb Ramps)

Main Street: WOOD DUCK CROSSING DR Cross Street: PINTAIL LANDING LN Intersection ID: 47455 Location: SW **Overall Compliance: No Severity Score:** 22.5 ADA ID: E0397AD8083E Ramp Type: PerpDiag Initial Pass/Fail: Fail

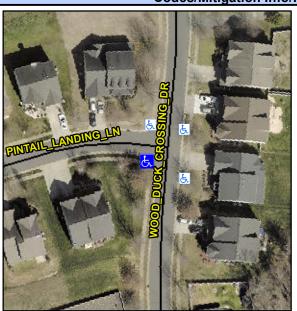
No Ramp Length (in) 47.5 Ramp Slope (%) No Ramp XSlope (%) Ramp Width (in) 47.5 N/A Flare Type LT N/A Flare Type RT N/A N/A Flare Slope RT (%) Flare Slope LT (%) Flare Traversable LT? N/A N/A Flare Traversable RT? N/A N/A **DWS Provided?** Landing Length (in) Landing Width (in) N/A N/A **DWS Contrast?** N/A N/A Landing Slope (%) DWS Length (in) Landing X Slope (%) N/A N/A DWS Full Width? Landing Curb? (Y/N) N/A N/A DWS Offset (in) N/A Shared Landing? **Gutter Ponding?** N/A N/A Gutter Slope (%) Gutter Lip Ht (in) N/A N/A Gutter X Slope (%) Painted X Walk1? No N/A Painted X Walk2? X Walk 1 Direction To NE X Walk 2 Direction To SE N/A X Walk 1 Width (in) X Walk 2 Width (in) X Walk 1 Slope (%) 0.7 X Walk 2 Slope (%) X Walk 1 X Slope (%) 4.4 X Walk 2 X Slope (%) N/A N/A Ramp inside XWalk2? Ramp inside XWalk1? Road Slope (%) 2.5 N/A Clear Space? N/A Road X Slope (%) 4.2 Clear Space to XWalk (in) N/A N/A N/A Any Obstructions? Storm Grate/Utility Hazard? **Obstruction Type** Storm Grate/Utility Type

Street 1 Name WOOD DUCK CROSSING DR Stop Condition-Street 2 None PINTAIL LANDING LN Street 2 Name Stop Condition-Street 1 StopSign Possible Solutions: Remove & Replace Curb Ramp With Two New Directional Ramps or Equivalent. Surveyor Notes: N/A PROW/ADA: Not Found, R304.5.1, R304.2.2, R304.5.3
