# Access Compliance Report

## Public Rights-of-Way

Intersection ID: 48463	Main Street: PANGLEMONT_DR	Cross Street: CHANDLER_HAVEN_DR	Location: S
ADA ID: E065CBB5CF34	Ramp Type: PerpDiag	Initial Pass/Fail: Fail	Overall Compliance: No
Severity Score: 13.75			
Codes/Mitigation Info/Possible Solution		Field Measurements/Component Compliance

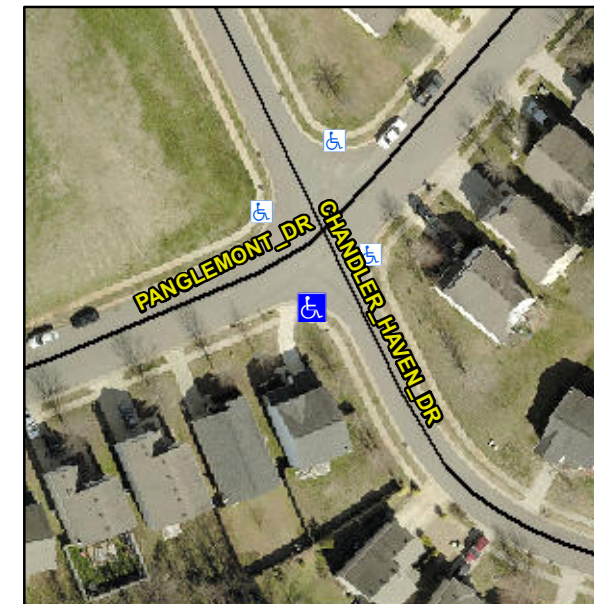
**Not Found, R304.2.2, R304.5.3**

Compliance	Description	Data	Compliance	Description	Data
N/A	Ramp Length (in)	45.5	No	Ramp Slope (%)	8.7
Yes	Ramp Width (in)	48.0	No	Ramp XSlope (%)	5.0
N/A	Flare Type LT	N/A	N/A	Flare Type RT	N/A
N/A	Flare Slope LT (%)	N/A	N/A	Flare Slope RT (%)	N/A
N/A	Flare Traversable LT?	N/A	N/A	Flare Traversable RT?	N/A
N/A	Landing Length (in)	N/A	N/A	DWS Provided?	N/A
N/A	Landing Width (in)	N/A	N/A	DWS Contrast?	N/A
N/A	Landing Slope (%)	N/A	N/A	DWS Length (in)	N/A
N/A	Landing X Slope (%)	N/A	N/A	DWS Full Width?	N/A
N/A	Landing Curb? (Y/N)	N/A	N/A	DWS Offset (in)	N/A
N/A	Shared Landing?	N/A			
N/A	Gutter Ponding?	N/A	N/A	Gutter Slope (%)	N/A
N/A	Gutter Lip Ht (in)	N/A	N/A	Gutter X Slope (%)	N/A
N/A	Painted X Walk1?	No	N/A	Painted X Walk2?	No
	X Walk 1 Direction	To NE		X Walk 2 Direction	To N
N/A	X Walk 1 Width (in)	N/A	N/A	X Walk 2 Width (in)	N/A
	X Walk 1 Slope (%)	0.6		X Walk 2 Slope (%)	4.0
	X Walk 1 X Slope (%)	4.2		X Walk 2 X Slope (%)	2.2

**Remove & Replace Curb Ramp With Two New Directional Ramps or Equivalent.**

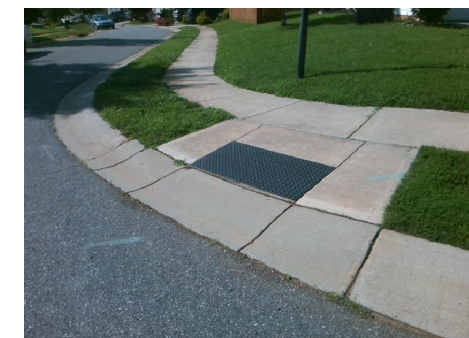
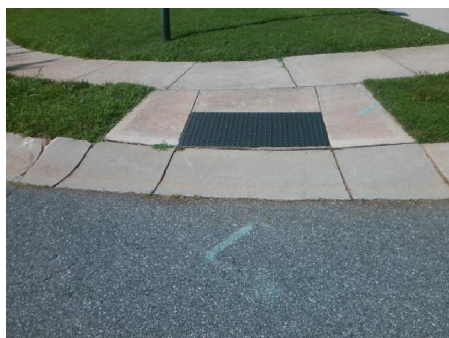
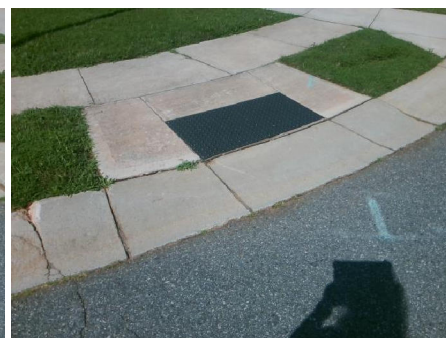
N/A	Ramp inside XWalk1?	N/A	N/A	Ramp inside XWalk2?	N/A
	Road Slope (%)	4.3	N/A	Clear Space?	N/A
	Road X Slope (%)	1.2	N/A	Clear Space to XWalk (in)	N/A
N/A	Any Obstructions?	N/A	N/A	Storm Grate/Utility Hazard?	N/A
	Obstruction Type			Storm Grate/Utility Type	
		N/A			N/A
			Yes	Surface Condition? (G/P)	Good
