## **Access Compliance Report Public Rights-of-Way** (Curb Ramps)

Intersection ID: 13916 Main Street: CLANTON RD **Cross Street: WEST BV** Location: NW Initial Pass/Fail: Fail **Overall Compliance: No Severity Score:** 25 ADA ID: E06B3563EC09 Ramp Type: Perp

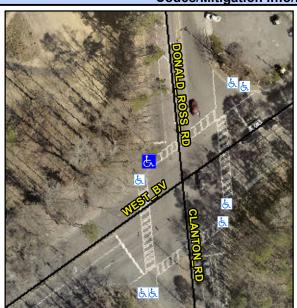
**DONALD ROSS RD** Street 1 Name Signal Stop Condition-Street 2 N/A Street 2 Name Stop Condition-Street 1 N/A Possible Solutions: Remove & Replace Entire Ramp. Surveyor Notes: N/A PROW/ADA: R304.2.2
