Access Compliance Report Public Rights-of-Way (Curb Ramps)

Intersection ID: 53351Main Street:MARVIN_RDCross Street:SAPPHIRE_HILL_LNLocation:NEADA ID: E0728D57E6C2Ramp Type:PerpInitial Pass/Fail:FailOverall Compliance:NoSeverity Score:10

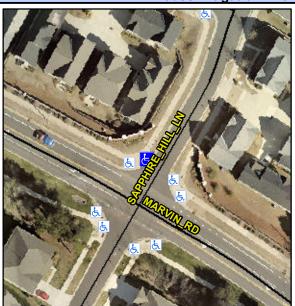
Field Measurements/Component Compliance						
Compliance Description		Data	Comp	liance Description	Data	
N/A	Ramp Length (in)	67.5	Yes	Ramp Slope (%)	5.3	
No	Ramp Width (in)	47.0	No	Ramp XSlope (%)	3.1	
N/A	Flare Type LT	N/A	N/A	Flare Type RT	N/A	
N/A	Flare Slope LT (%)	N/A	N/A	Flare Slope RT (%)	N/A	
N/A	Flare Traversable LT?	N/A	N/A	Flare Traversable RT?	N/A	
N/A	Landing Length (in)	N/A	N/A	DWS Provided?	N/A	
N/A	Landing Width (in)	N/A	N/A	DWS Contrast?	N/A	
N/A	Landing Slope (%)	N/A	N/A	DWS Length (in)	N/A	
N/A	Landing X Slope (%)	N/A	N/A	DWS Full Width?	N/A	
N/A	Landing Curb? (Y/N)	N/A	N/A	DWS Offset (in)	N/A	
N/A	Shared Landing?	N/A				
N/A	Gutter Ponding?	N/A	N/A	Gutter Slope (%)	N/A	
N/A	Gutter Lip Ht (in)	N/A	N/A	Gutter X Slope (%)	N/A	
N/A	Painted X Walk1?	No	N/A	Painted X Walk2?	N/A	
	X Walk 1 Direction	To SE		X Walk 2 Direction	N/A	
N/A	X Walk 1 Width (in)	N/A	N/A	X Walk 2 Width (in)	N/A	
	X Walk 1 Slope (%)	3.8		X Walk 2 Slope (%)	N/A

X Walk 1 X Slope (%)	4.4		X Walk 2 X Slope (%)	N/A	
N/A	Ramp inside XWalk1?	N/A	N/A	Ramp inside XWalk2?	N/A	
	Road Slope (%)	N/A	N/A	Clear Space?	N/A	
	Road X Slope (%)	N/A	N/A	Clear Space to XWalk (in)	N/A	
N/A	Any Obstructions?	N/A	N/A	Storm Grate/Utility Hazard?	N/A	
	Obstruction Type			Storm Grate/Utility Type		
		N/A			N/A	
			Yes	Surface Condition? (G/P)	Good

Possible Solutions:			
Remove & Replace Entire Ramp.			
•	N		
	N		
	N		
	1		
	1		
Surveyor Notes:	N		
N/A	N		
	N		
	N		
	N		
PROW/ADA:	N		
Not Found, R304.5.1, R304.5.3	N		
	1		
	1

Total Cost: \$ 1850.00
