Access Compliance Report

Public Rights-of-Way

(Curb Ramps)

Intersection ID: 12165	Main Street: E_15TH_ST	Cross Street: HARRILL_ST	Location: S
ADA ID: E079FCAAB50B	Ramp Type: PerpDiag	Initial Pass/Fail: Fail	Overall Compliance: No
		Severity Score: 8.75

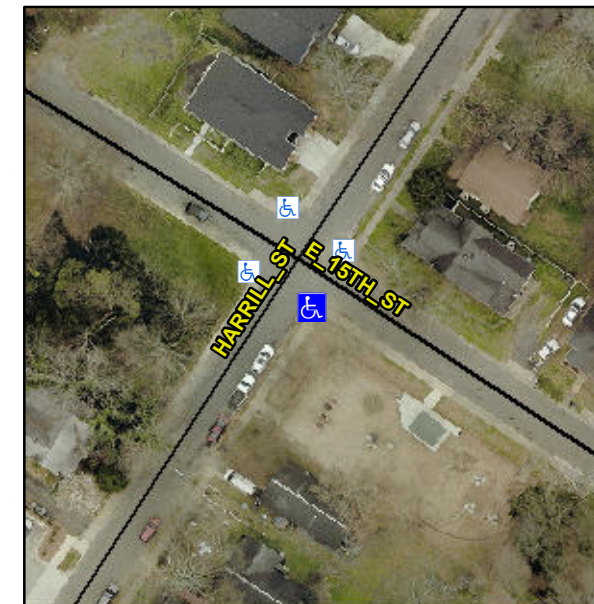
Compliance	Description	Data	Compliance	Description	Data
N/A	Ramp Length (in)	36.0	Yes	Ramp Slope (%)	5.4
No	Ramp Width (in)	39.0	Yes	Ramp XSlope (%)	0.9
N/A	Flare Type LT	N/A	N/A	Flare Type RT	N/A
N/A	Flare Slope LT (%)	N/A	N/A	Flare Slope RT (%)	N/A
N/A	Flare Traversable LT?	N/A	N/A	Flare Traversable RT?	N/A
N/A	Landing Length (in)	N/A	N/A	DWS Provided?	N/A
N/A	Landing Width (in)	N/A	N/A	DWS Contrast?	N/A
N/A	Landing Slope (%)	N/A	N/A	DWS Length (in)	N/A
N/A	Landing X Slope (%)	N/A	N/A	DWS Full Width?	N/A
N/A	Landing Curb? (Y/N)	N/A	N/A	DWS Offset (in)	N/A
N/A	Shared Landing?	N/A			
N/A	Gutter Ponding?	Yes	N/A	Gutter Slope (%)	N/A
N/A	Gutter Lip Ht (in)	0.5	N/A	Gutter X Slope (%)	N/A
N/A	Painted X Walk1?	No	N/A	Painted X Walk2?	No
	X Walk 1 Direction	To NE		X Walk 2 Direction	To NW
N/A	X Walk 1 Width (in)	N/A	N/A	X Walk 2 Width (in)	N/A
	X Walk 1 Slope (%)	3.4		X Walk 2 Slope (%)	1.9
	X Walk 1 X Slope (%)	0.2		X Walk 2 X Slope (%)	0.2

N/A	Ramp inside XWalk1?	N/A	N/A	Ramp inside XWalk2?	N/A
	Road Slope (%)	0.3	N/A	Clear Space?	N/A
	Road X Slope (%)	2.7	N/A	Clear Space to XWalk (in)	N/A
N/A	Any Obstructions?	N/A	N/A	Storm Grate/Utility Hazard?	N/A
	Obstruction Type			Storm Grate/Utility Type	
		N/A			N/A
		Yes		Surface Condition? (G/P)	Good

Remove & Replace Curb Ramp With Two New Directional Ramps or Equivalent.

R304.5.1
