Access Compliance Report Public Rights-of-Way (Curb Ramps)

Intersection ID: 14704 Main Street: BELGRAVE_PL Cross Street: ROMANY_RD Location: SE

ADA ID: E07D61F902AC Ramp Type: Para Initial Pass/Fail: Fail Overall Compliance: No Severity Score: 13.75

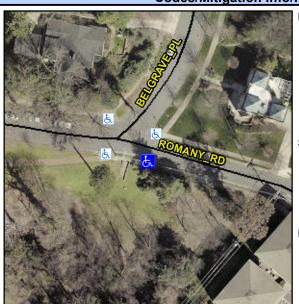
LT RP < 5%

R304.5.3, R304.3.2

rield Measurements/Component Compilance						
Compliance Description Data			Compliance Description D			
N/A	Ramp Length LT (in)	72.0	N/A	Ramp Length RT (in)	72.0	
Yes	Ramp Width LT (in)	77.0	Yes	Ramp Width RT (in)	77.0	
Yes	Ramp Slope LT (%)	1.5	No	Ramp Slope RT (%)	9.8	
No	Ramp XSlope LT (%)	2.8	Yes	Ramp XSlope RT (%)	0.6	
N/A	Landing Length (in)	N/A	N/A	DWS Provided?	N/A	
N/A	Landing Width (in)	N/A	N/A	DWS Contrast?	N/A	
N/A	Landing Slope (%)	N/A	N/A	DWS Length (in)	N/A	
N/A	Landing X Slope (%)	N/A	N/A	DWS Full Width?	N/A	
N/A	Landing Curb? (Y/N)	N/A	N/A	DWS Offset (in)	N/A	
N/A	Shared Landing?	N/A				
N/A	Gutter Ponding?	N/A	N/A	Gutter Slope (%)	N/A	
N/A	Gutter Lip Ht (in)	N/A	N/A	Gutter X Slope (%)	N/A	
N/A	Painted X Walk1?	No	N/A	Painted X Walk2?	N/A	
	X Walk 1 Direction	To N		X Walk 2 Direction	N/A	
N/A	X Walk 1 Width (in)	N/A	N/A	X Walk 2 Width (in)	N/A	
	X Walk 1 Slope (%)	6.2		X Walk 2 Slope (%)	N/A

X Walk 1 X Slope (%)	2.8		X Walk 2 X Slope (%)	N/A	
N/A	Ramp inside XWalk1?	N/A	N/A	Ramp inside XWalk2?	N/A	
	Road Slope (%)	N/A	N/A	Clear Space?	N/A	
	Road X Slope (%)	N/A	N/A	Clear Space to XWalk (in)	N/A	
N/A	Any Obstructions?	N/A	N/A	Storm Grate/Utility Hazard?	N/A	
	Obstruction Type			Storm Grate/Utility Type		
		N/A			N/A	
			Yes	Surface Condition? (G/P)	Good	
			N/A	Curb Slope (%)	13.3

Remove & Replace Entire Ramp.

1600.00
