Access Compliance Report Public Rights-of-Way (Curb Ramps)

Intersection ID: 8125Main Street:CROSSRIDGE_RDCross Street:EAGLE_PEAK_DRLocation:N/AADA ID: E085FB4B0D90Ramp Type:PerpInitial Pass/Fail:FailOverall Compliance:NoSeverity Score:22.5

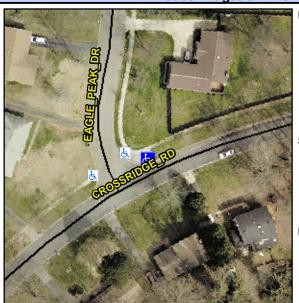
Field Measurements/Component Compliance							
Comp	liance Description	Data	Comp	liance Description	Data		
N/A	Ramp Length (in)	132.0	No	Ramp Slope (%)	8.4		
No	Ramp Width (in)	45.0	No	Ramp XSlope (%)	4.1		
N/A	Flare Type LT	N/A	N/A	Flare Type RT	N/A		
N/A	Flare Slope LT (%)	N/A	N/A	Flare Slope RT (%)	N/A		
N/A	Flare Traversable LT?	N/A	N/A	Flare Traversable RT?	N/A		
N/A	Landing Length (in)	N/A	N/A	DWS Provided?	N/A		
N/A	Landing Width (in)	N/A	N/A	DWS Contrast?	N/A		
N/A	Landing Slope (%)	N/A	N/A	DWS Length (in)	N/A		
N/A	Landing X Slope (%)	N/A	N/A	DWS Full Width?	N/A		
N/A	Landing Curb? (Y/N)	N/A	N/A	DWS Offset (in)	N/A		
N/A	Shared Landing?	N/A					
N/A	Gutter Ponding?	N/A	N/A	Gutter Slope (%)	N/A		
N/A	Gutter Lip Ht (in)	N/A	N/A	Gutter X Slope (%)	N/A		
N/A	Painted X Walk1?	No	N/A	Painted X Walk2?	N/A		
	X Walk 1 Direction	To S		X Walk 2 Direction	N/A		
N/A	X Walk 1 Width (in)	N/A	N/A	X Walk 2 Width (in)	N/A

X Walk 1 Slope (%)	6.2		X Walk 2 Slope (%)	N/A		
	X Walk 1 X Slope (%)	2.9		X Walk 2 X Slope (%)	N/A		
N/A	Ramp inside XWalk1?	N/A	N/A	Ramp inside XWalk2?	N/A		
	Road Slope (%)	2.9	N/A	Clear Space?	N/A		
	Road X Slope (%)	6.2	N/A	Clear Space to XWalk (in)	N/A		
N/A	Any Obstructions?	N/A	N/A	Storm Grate/Utility Hazard?	N/A		
	Obstruction Type			Storm Grate/Utility Type			
		N/A			N/A		
			Yes	Surface Condition? (G/P)	Good

ossible Solutions:	9	
Remove & Replace Entire Ramp.		
·	ı	
	1	
	ı	
	ı	
	ı	
urveyor Notes:	ı	
N/A	ı	
	ı	
	ı	
	ı	
ROW/ADA:	ı	
Not Found, R304.5.1, R304.2.2,	1	
R304.5.3	ı	
	ı

Total Cost:	\$ 1850.00
