# Access Compliance Report

## Public Rights-of-Way

### (Curb Ramps)

Intersection ID: 7008	Main Street: MCALLISTER_DR	Cross Street: MERRILL_PL	Location: SW
ADA ID: E08BFAC35B28	Ramp Type: Perp	Initial Pass/Fail: Fail	Overall Compliance: No
			Severity Score: 33.75

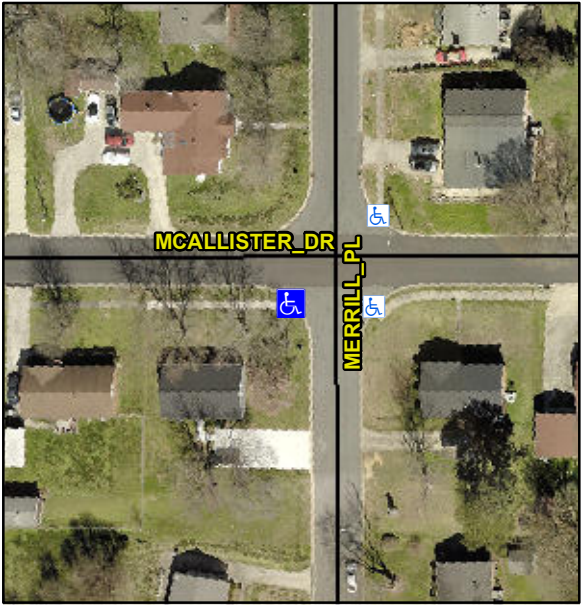
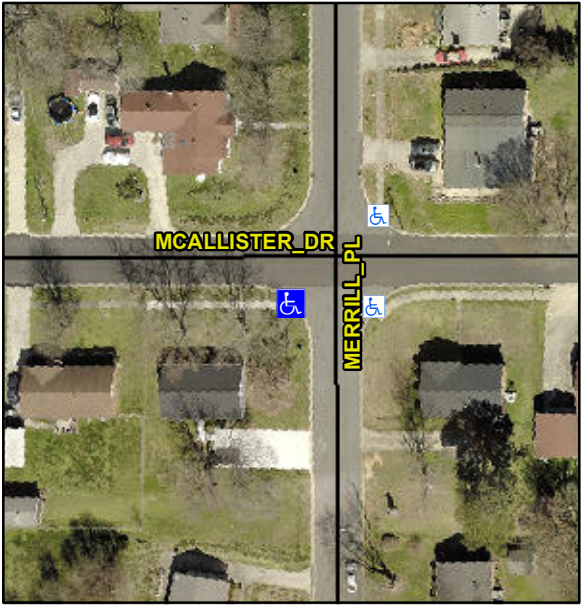
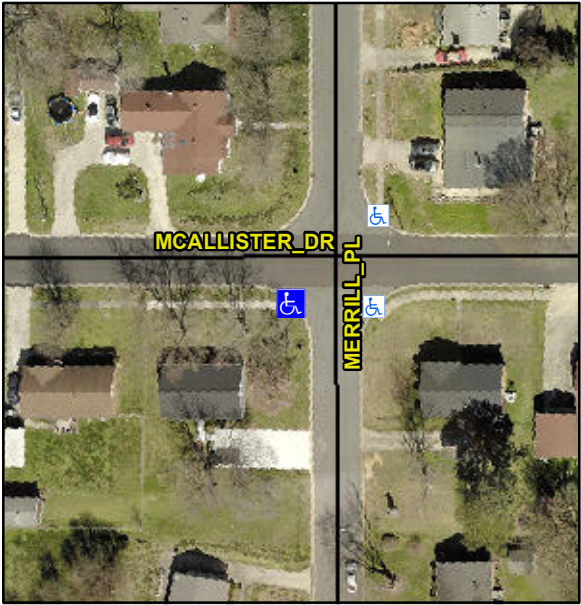
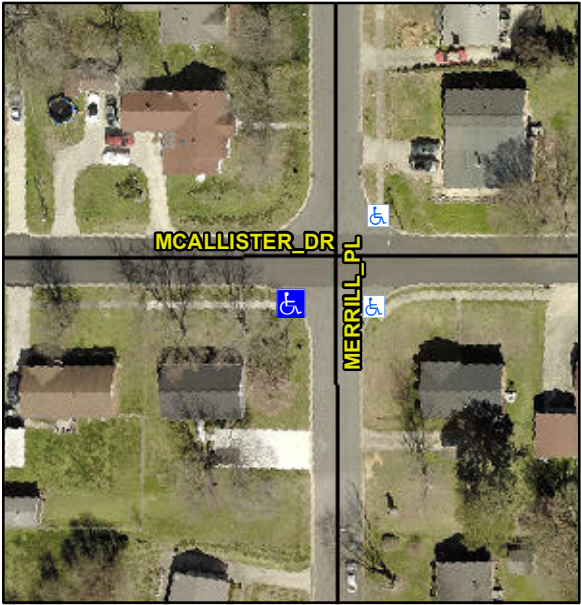
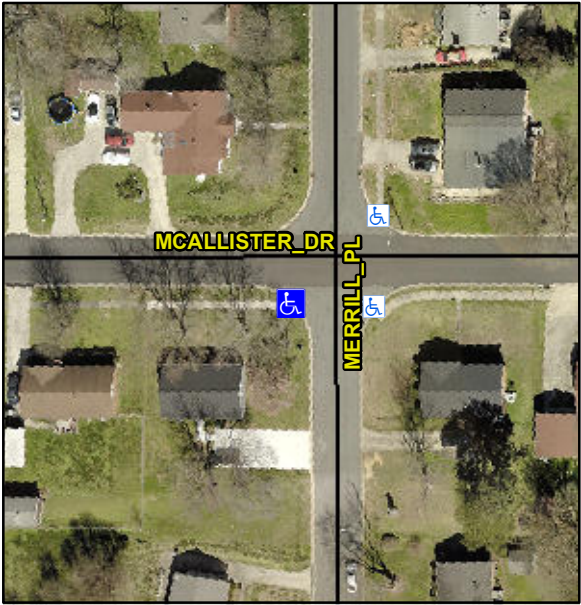
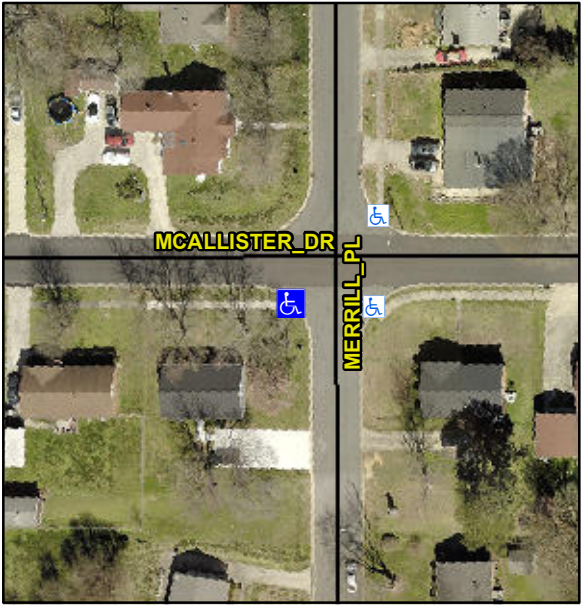
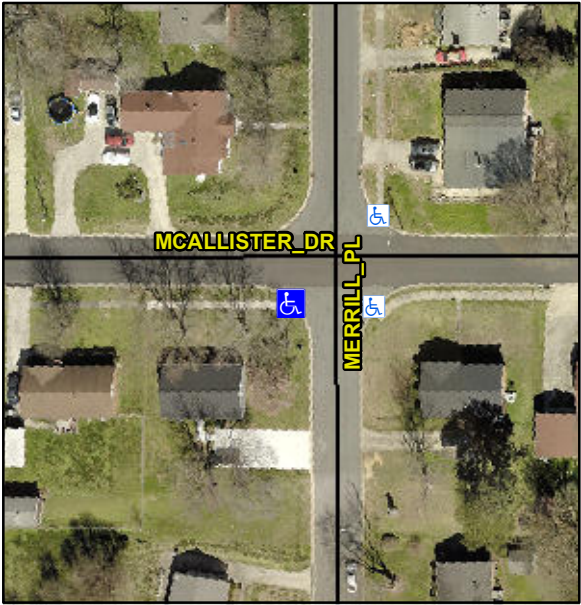
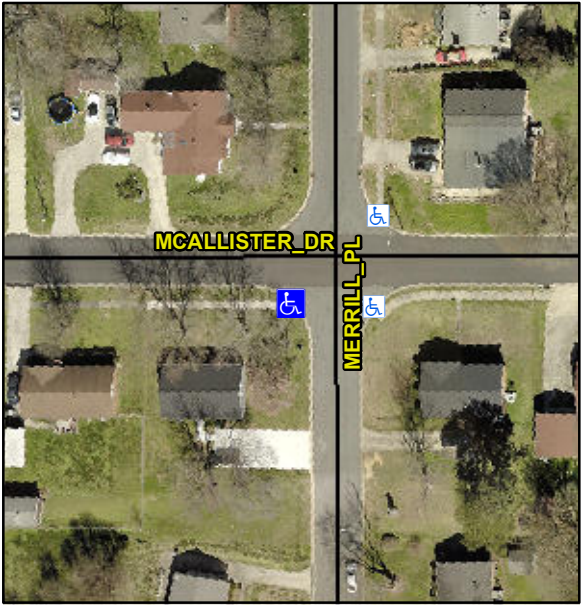
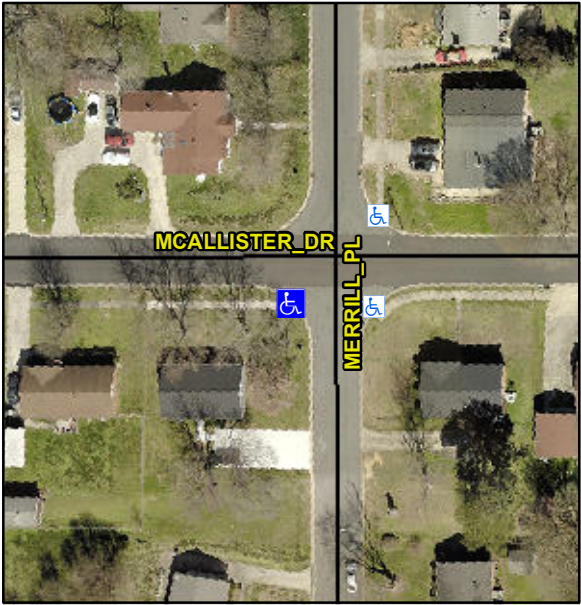
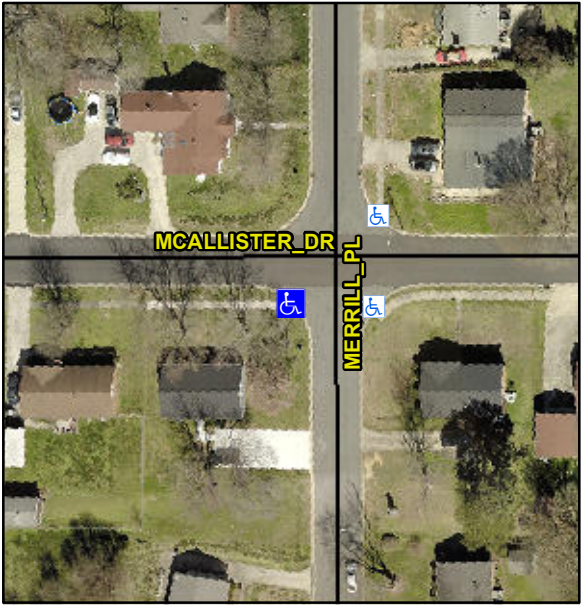
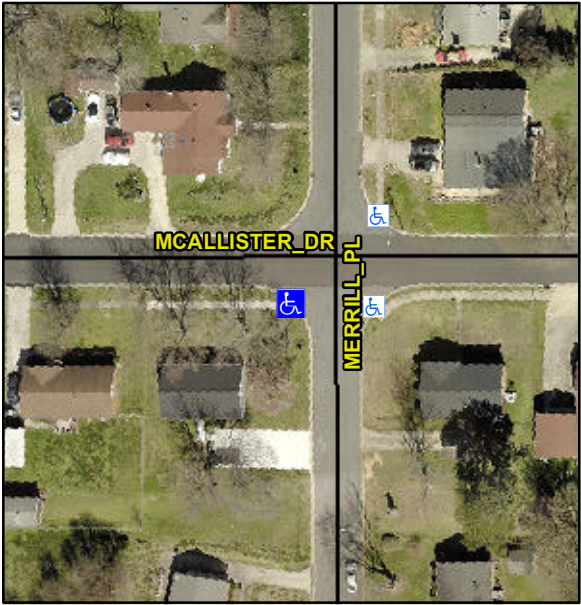
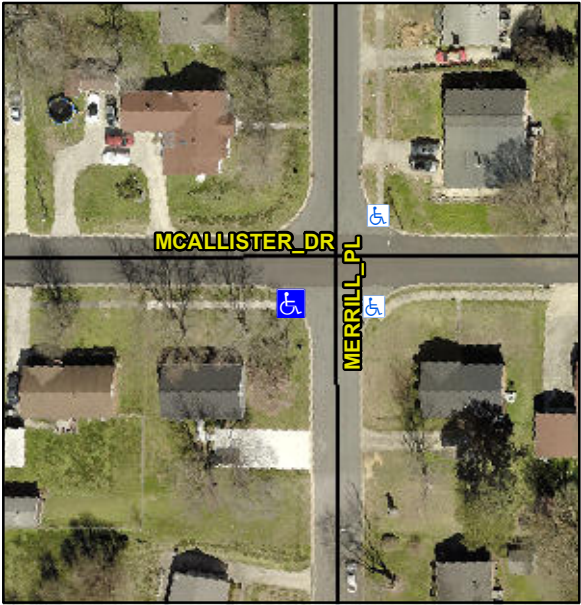
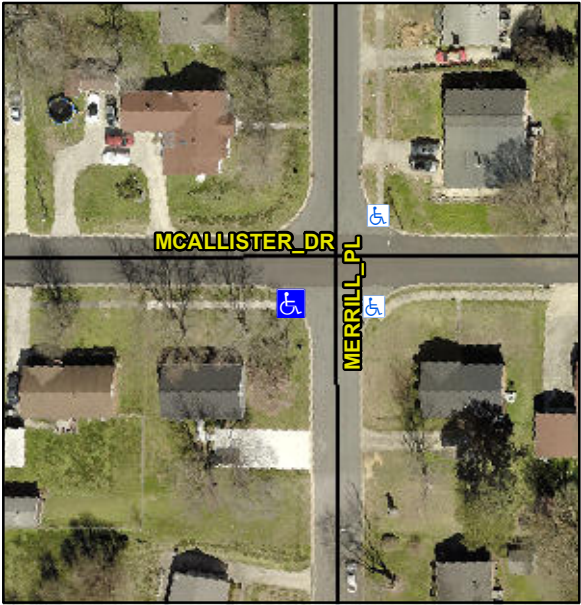
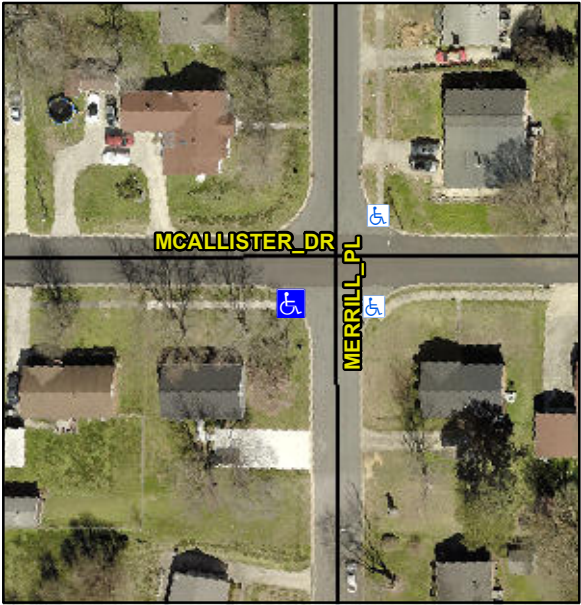
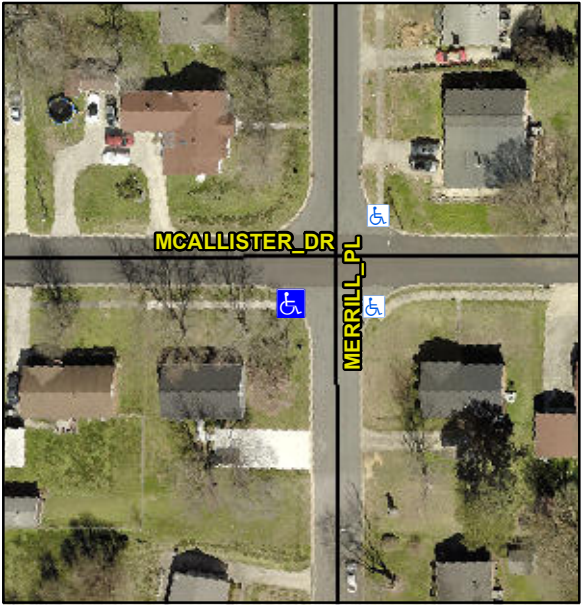
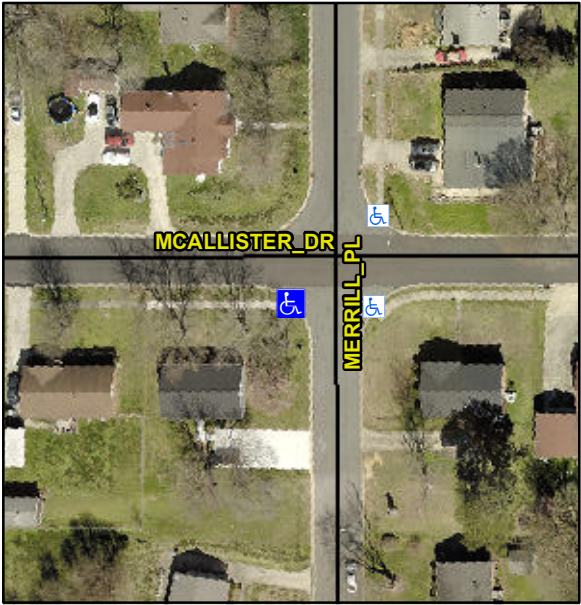
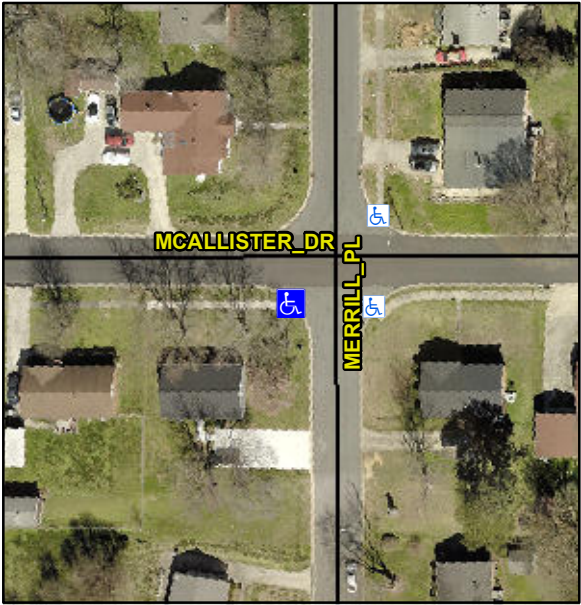
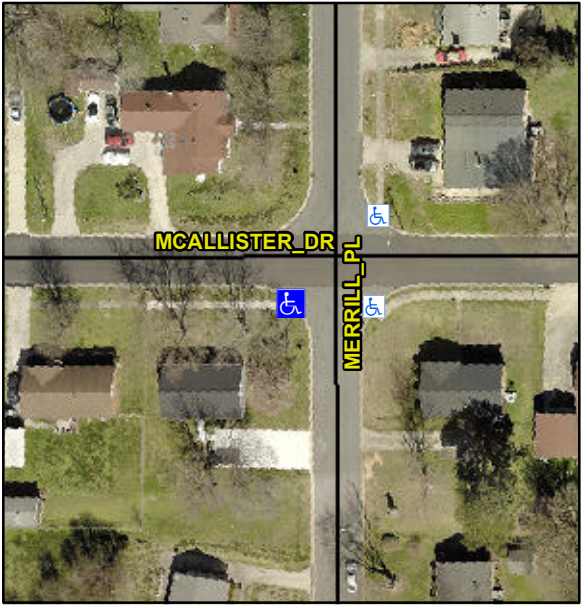
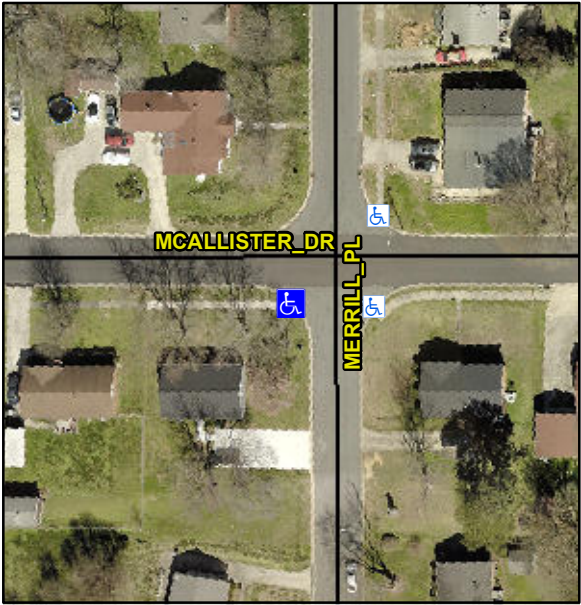
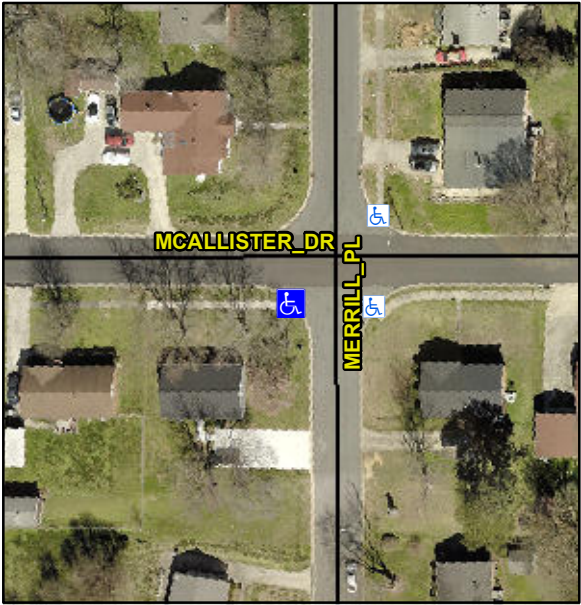
Possible Solutions:		<b>Compliance</b>	<b>Description</b>	<b>Data</b>
	<b>Remove &amp; Replace Entire Ramp.</b>		<b>Yes</b>	<b>Ramp Slope (%)</b>	<b>5.5</b>

Surveyor Notes:		<b>No</b>	<b>Ramp XSlope (%)</b>	<b>10.4</b>
	<b>N/A</b>		<b>N/A</b>	<b>Flare Type LT</b>	<b>N/A</b>

PROW/ADA:		<b>N/A</b>	<b>Flare Slope LT (%)</b>	<b>N/A</b>
	<b>Not Found, R304.5.1, R304.5.3</b>		<b>N/A</b>	<b>Flare Slope RT (%)</b>	<b>N/A</b>

Total Cost: \$ 1850.00
