# Access Compliance Report

## Public Rights-of-Way

### (Curb Ramps)

Intersection ID: 16191	Main Street: BELTON_ST	Cross Street: HARTFORD_AV	Location: E
ADA ID: E0A22B1EFF0A	Ramp Type: PerpDiag	Initial Pass/Fail: Pass	Overall Compliance: No
			Severity Score: 15.25

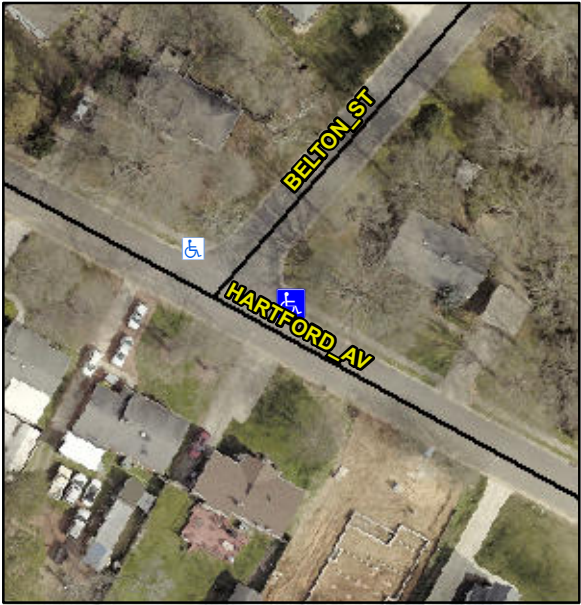
Compliance	Description	Data	Compliance	Description	Data
N/A	Ramp Length (in)	59.0	Yes	Ramp Slope (%)	7.3
Yes	Ramp Width (in)	48.0	No	Ramp XSlope (%)	3.3
N/A	Flare Type LT	Sloped	N/A	Flare Type RT	N/A
N/A	Flare Slope LT (%)	2.8	Yes	Flare Slope RT (%)	1.6
N/A	Flare Traversable LT?	No	N/A	Flare Traversable RT?	Yes
No	Landing Length (in)	N/A	Yes	DWS Provided?	Yes
No	Landing Width (in)	N/A	Yes	DWS Contrast?	Yes
No	Landing Slope (%)	N/A	Yes	DWS Length (in)	24.0
No	Landing X Slope (%)	N/A	Yes	DWS Full Width?	Yes
N/A	Landing Curb? (Y/N)	No	Yes	DWS Offset (in)	1.5
N/A	Shared Landing?	N/A			
Yes	Gutter Ponding?	No	No	Gutter Slope (%)	6.4
Yes	Gutter Lip Ht (in)	0.0	No	Gutter X Slope (%)	2.5
N/A	Painted X Walk1?	No	N/A	Painted X Walk2?	No
	X Walk 1 Direction	To NW		X Walk 2 Direction	To SW
N/A	X Walk 1 Width (in)	N/A	N/A	X Walk 2 Width (in)	N/A
	X Walk 1 Slope (%)	5.2		X Walk 2 Slope (%)	3.4
	X Walk 1 X Slope (%)	1.3		X Walk 2 X Slope (%)	4.4

N/A	Ramp inside XWalk1?	N/A	N/A	Ramp inside XWalk2?	N/A
	Road Slope (%)	0.9	N/A	Clear Space?	Yes
	Road X Slope (%)	6.5	N/A	Clear Space to XWalk (in)	N/A
Yes	Any Obstructions?	No	Yes	Storm Grate/Utility Hazard?	No
	Obstruction Type			Storm Grate/Utility Type	
		N/A			N/A
			Yes	Surface Condition? (G/P)	Good

<p>Possible Solutions:</p> <p><b>Remove &amp; Replace Curb Ramp With Two New Directional Ramps or Equivalent. Remove &amp; Replace Gutter.</b></p>	Compliance	Description	Data	
	<p>Surveyor Notes:</p> <p><b>N/A</b></p>				
	<p>PROW/ADA:</p> <p><b>Not Found, R304.5.3, R304.2.1, R304.2.2-Perp, R304.3.2-Para, R304.5.4</b></p>				
Street 1 Name	BELTON ST				
Stop Condition-Street 2	StopSign				
Street 2 Name	HARTFORD AV				
Stop Condition-Street 1	None				
Total Cost:	\$ 3950.00
