Access Compliance Report

Public Rights-of-Way

(Curb Ramps)

Intersection ID: 9278	Main Street: OAKLAWN_AV	Cross Street: BOOKER_AV	Location:	E
ADA ID: E0A884CE0CD8	Ramp Type: Perp	Initial Pass/Fail: Fail	Overall Compliance: No	Severity Score: 10
Codes/Mitigation Info/Possible Solution		Field Measurements/Component Compliance

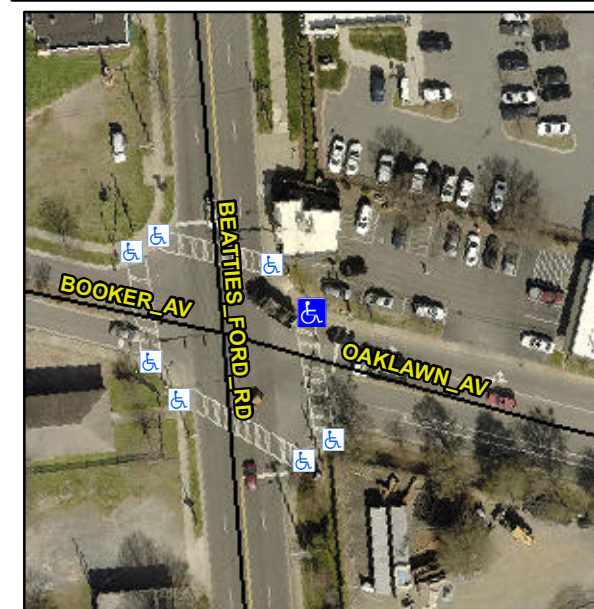
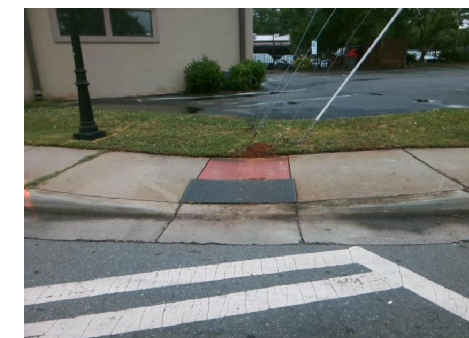
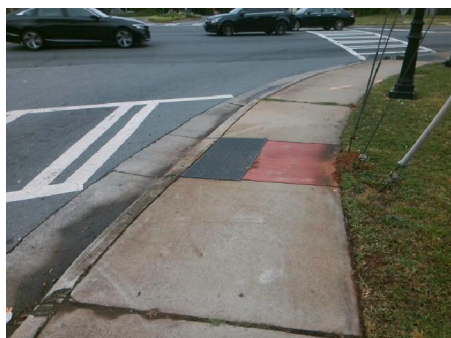
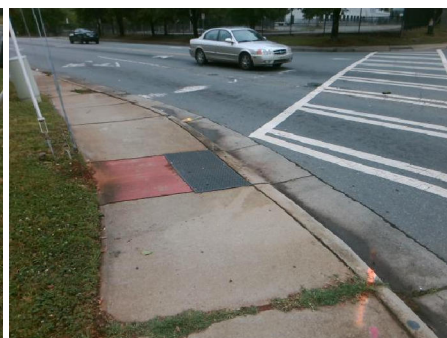
Not Found, R304.5.1, R304.5.3

Compliance	Description	Data	Compliance	Description	Data
N/A	Ramp Length (in)	59.5	Yes	Ramp Slope (%)	5.6
No	Ramp Width (in)	43.0	No	Ramp XSlope (%)	2.8
N/A	Flare Type LT	N/A	N/A	Flare Type RT	N/A
N/A	Flare Slope LT (%)	N/A	N/A	Flare Slope RT (%)	N/A
N/A	Flare Traversable LT?	N/A	N/A	Flare Traversable RT?	N/A
N/A	Landing Length (in)	N/A	N/A	DWS Provided?	N/A
N/A	Landing Width (in)	N/A	N/A	DWS Contrast?	N/A
N/A	Landing Slope (%)	N/A	N/A	DWS Length (in)	N/A
N/A	Landing X Slope (%)	N/A	N/A	DWS Full Width?	N/A
N/A	Landing Curb? (Y/N)	N/A	N/A	DWS Offset (in)	N/A
N/A	Shared Landing?	N/A			
N/A	Gutter Ponding?	N/A	N/A	Gutter Slope (%)	N/A
N/A	Gutter Lip Ht (in)	N/A	N/A	Gutter X Slope (%)	N/A
N/A	Painted X Walk1?	Yes	N/A	Painted X Walk2?	N/A
	X Walk 1 Direction	To S		X Walk 2 Direction	N/A
N/A	X Walk 1 Width (in)	113.5	N/A	X Walk 2 Width (in)	N/A
	X Walk 1 Slope (%)	2.2		X Walk 2 Slope (%)	N/A
	X Walk 1 X Slope (%)	1.6		X Walk 2 X Slope (%)	N/A

N/A	Ramp inside XWalk1?	Yes	N/A	Ramp inside XWalk2?	N/A
	Road Slope (%)	N/A	N/A	Clear Space?	N/A
	Road X Slope (%)	N/A	N/A	Clear Space to XWalk (in)	N/A
N/A	Any Obstructions?	N/A	N/A	Storm Grate/Utility Hazard?	N/A
	Obstruction Type			Storm Grate/Utility Type	
		N/A			N/A
			Yes	Surface Condition? (G/P)	Good

Possible Solutions:

Remove & Replace Entire Ramp.
