Access Compliance Report

Public Rights-of-Way

(Curb Ramps)

Intersection ID: 13408		Main Street: COMMONWEALTH_AV		Cross Street: THE_PLAZA		Location: E											
ADA ID: E0ACC28911CB		Ramp Type: Directional1		Initial Pass/Fail: Fail		Overall Compliance: No		Severity Score: 22.5									
Codes/Mitigation Info/Possible Solution				Field Measurements/Component Compliance													
<div>

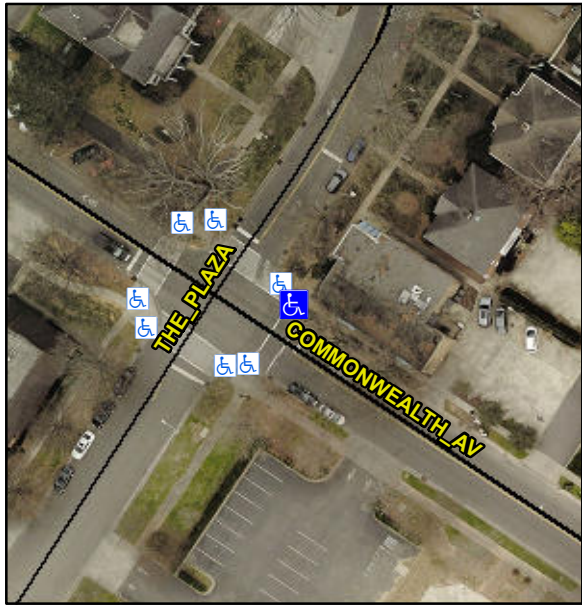
</div> <div>Possible Solutions:</div> <div>Remove & Replace Entire Ramp.</div> <div>Surveyor Notes:</div> <div>N/A</div> <div>PROW/ADA:</div> <div>R304.5.1, R304.2.2, R304.5.3</div> <div>Street 1 NameCOMMONWEALTH AV</div> <div>Stop Condition-Street 1StopSign</div> <div>Street 2 NameN/A</div> <div>Stop Condition-Street 2N/A</div> <div>Total Cost:\$1600.00</div>				Compliance		Description		Data		Compliance		Description		Data			
				N/A		Ramp Length (in)		49.5		N/A		Grade Break?		N/A			
				No		Ramp Width (in)		47.5		N/A		Grade Break Slope (%)		0.0			
				No		Ramp Slope (%)		11.5		N/A		Grade Break XSlope (%)		0.0

No		Ramp XSlope (%)		2.5									
				N/A		Flare Type LT		N/A		N/A		Flare Type RT		N/A			
				N/A		Flare Slope LT (%)		N/A		N/A		Flare Slope RT (%)		0.0			
				N/A		Flare Traversable LT?		N/A		N/A		Flare Traversable RT?		N/A			
				N/A		Landing Length (in)		0.0		N/A		DWS Provided?		N/A			
				N/A		Landing Width (in)		0.0		N/A		DWS Contrast?		N/A			
				N/A		Landing Slope (%)		0.0		N/A		DWS Length (in)		N/A			
				N/A		Landing X Slope (%)		0.0		N/A		DWS Full Width?		N/A			
				N/A		Landing Curb? (Y/N)		N/A		N/A		DWS Offset LT (in)		N/A			
				N/A		Shared Landing?		N/A		N/A		DWS Offset RT (in)		N/A			
				N/A		Gutter Ponding?		0.0		N/A		Gutter Slope (%)		N/A			
				N/A		Gutter Lip Ht (in)		0.0		N/A		Gutter X Slope (%)		N/A			
				N/A		Painted X Walk1?		Yes				Road Slope (%)		1.8			
						X Walk 1 Direction		To SW				Road X Slope (%)		1.8			
						X Walk 1 Width (in)		110.0				Clear Space?		N/A			
						X Walk 1 Slope (%)		1.8		N/A		Clear Space to XWalk (in)		N/A

X Walk 1 X Slope (%)		1.8		N/A		Storm Grate/Utility Hazard?		N/A			
				N/A		Ramp inside XWalk1?		Yes				Storm Grate/Utility Type					
				N/A		Any Obstructions?		N/A						N/A			
						Obstruction Type				Yes		Surface Condition? (G/P)		Good			
										N/A		N/A		Curb Slope (%)		11.1
