# Access Compliance Report

## Public Rights-of-Way

### (Curb Ramps)

Intersection ID: N/A	Main Street: BROOKSVALE_ST	Cross Street: N/A	Location: NW
ADA ID: E0ADA7E0FF45	Ramp Type: Perp	Initial Pass/Fail: Fail	Overall Compliance: No
Severity Score: 13.75			
Codes/Mitigation Info/Possible Solution		Field Measurements/Component Compliance

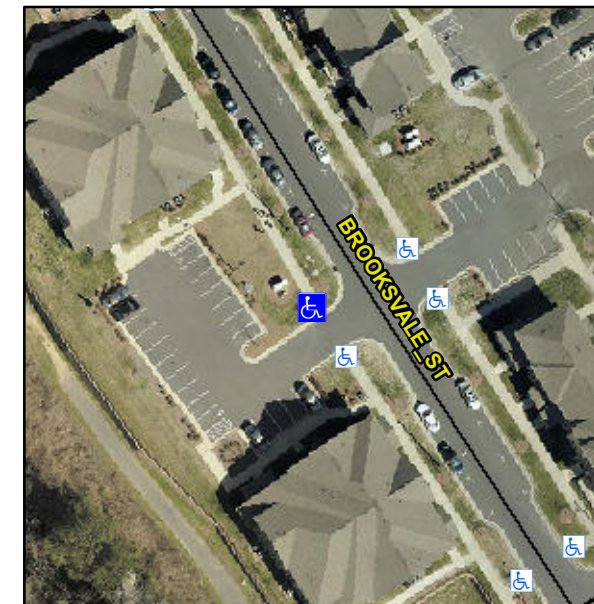
**R304.2.2, R304.5.3**

Compliance	Description	Data	Compliance	Description	Data
N/A	Ramp Length (in)	73.0	No	Ramp Slope (%)	8.9
Yes	Ramp Width (in)	70.0	No	Ramp XSlope (%)	3.0
N/A	Flare Type LT	N/A	N/A	Flare Type RT	N/A
N/A	Flare Slope LT (%)	N/A	N/A	Flare Slope RT (%)	N/A
N/A	Flare Traversable LT?	N/A	N/A	Flare Traversable RT?	N/A
N/A	Landing Length (in)	N/A	N/A	DWS Provided?	N/A
N/A	Landing Width (in)	N/A	N/A	DWS Contrast?	N/A
N/A	Landing Slope (%)	N/A	N/A	DWS Length (in)	N/A
N/A	Landing X Slope (%)	N/A	N/A	DWS Full Width?	N/A
N/A	Landing Curb? (Y/N)	N/A	N/A	DWS Offset (in)	N/A
N/A	Shared Landing?	N/A			
N/A	Gutter Ponding?	N/A	N/A	Gutter Slope (%)	N/A
N/A	Gutter Lip Ht (in)	N/A	N/A	Gutter X Slope (%)	N/A
N/A	Painted X Walk1?	No	N/A	Painted X Walk2?	N/A
	X Walk 1 Direction	To S		X Walk 2 Direction	N/A
N/A	X Walk 1 Width (in)	N/A	N/A	X Walk 2 Width (in)	N/A
	X Walk 1 Slope (%)	1.8		X Walk 2 Slope (%)	N/A
	X Walk 1 X Slope (%)	0.9		X Walk 2 X Slope (%)	N/A

N/A	Ramp inside XWalk1?	N/A	N/A	Ramp inside XWalk2?	N/A
	Road Slope (%)	N/A	N/A	Clear Space?	N/A
	Road X Slope (%)	N/A	N/A	Clear Space to XWalk (in)	N/A
N/A	Any Obstructions?	N/A	N/A	Storm Grate/Utility Hazard?	N/A
	Obstruction Type			Storm Grate/Utility Type	
		N/A			N/A
		Yes		Surface Condition? (G/P)	Good

Possible Solutions:

**Remove & Replace Entire Ramp.**

Total Cost: \$ 1850.00
