# Access Compliance Report

## Public Rights-of-Way

### (Curb Ramps)

Intersection ID: 14289	Main Street: E_7TH_ST	Cross Street: RIDGEWAY_AV	Location: SW
ADA ID: E0B32BFE834B	Ramp Type: PerpDiag	Initial Pass/Fail: Fail	Overall Compliance: No
Severity Score: 35			
Codes/Mitigation Info/Possible Solution		Field Measurements/Component Compliance

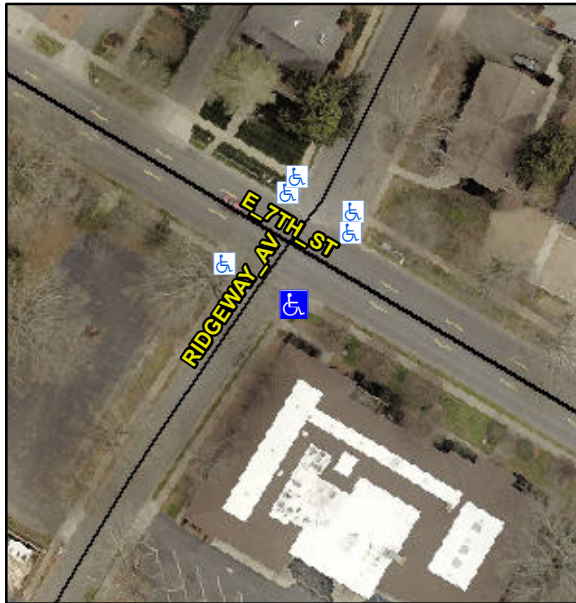
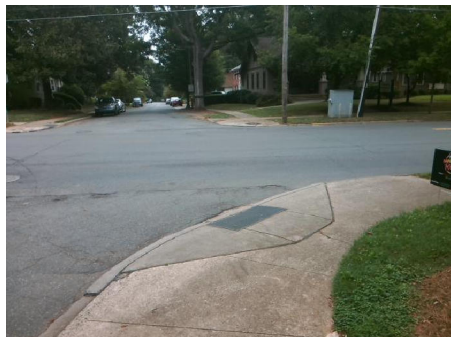
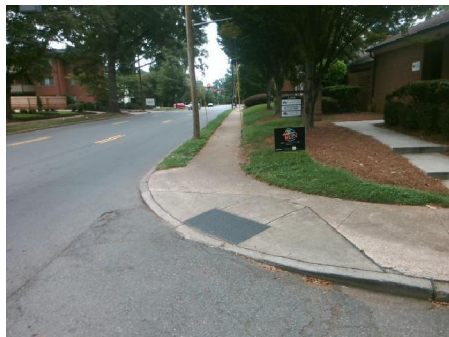
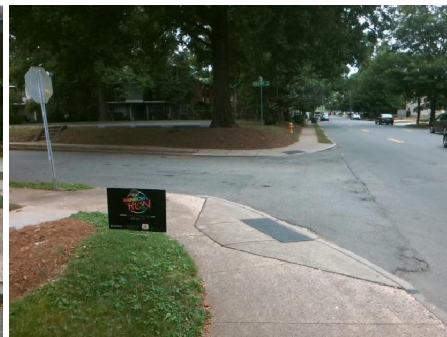
**Not Found, R304.5.1, R304.2.2, R304.5.3**

Compliance	Description	Data	Compliance	Description	Data
N/A	Ramp Length (in)	48.0	No	Ramp Slope (%)	14.0
No	Ramp Width (in)	37.0	No	Ramp XSlope (%)	3.7
N/A	Flare Type LT	N/A	N/A	Flare Type RT	N/A
N/A	Flare Slope LT (%)	N/A	N/A	Flare Slope RT (%)	N/A
N/A	Flare Traversable LT?	N/A	N/A	Flare Traversable RT?	N/A
N/A	Landing Length (in)	N/A	N/A	DWS Provided?	N/A
N/A	Landing Width (in)	N/A	N/A	DWS Contrast?	N/A
N/A	Landing Slope (%)	N/A	N/A	DWS Length (in)	N/A
N/A	Landing X Slope (%)	N/A	N/A	DWS Full Width?	N/A
N/A	Landing Curb? (Y/N)	N/A	N/A	DWS Offset (in)	N/A
N/A	Shared Landing?	N/A			
N/A	Gutter Ponding?	N/A	N/A	Gutter Slope (%)	N/A
N/A	Gutter Lip Ht (in)	N/A	N/A	Gutter X Slope (%)	N/A
N/A	Painted X Walk1?	No	N/A	Painted X Walk2?	No
	X Walk 1 Direction	To NE		X Walk 2 Direction	To NW
N/A	X Walk 1 Width (in)	N/A	N/A	X Walk 2 Width (in)	N/A
	X Walk 1 Slope (%)	1.3		X Walk 2 Slope (%)	0.3
	X Walk 1 X Slope (%)	1.5		X Walk 2 X Slope (%)	1.0

N/A	Ramp inside XWalk1?	N/A	N/A	Ramp inside XWalk2?	N/A
	Road Slope (%)	3.7	N/A	Clear Space?	N/A
	Road X Slope (%)	0.4	N/A	Clear Space to XWalk (in)	N/A
N/A	Any Obstructions?	N/A	N/A	Storm Grate/Utility Hazard?	N/A
	Obstruction Type			Storm Grate/Utility Type	
		N/A			N/A
			Yes	Surface Condition? (G/P)	Good

**Remove & Replace Curb Ramp With Two New Directional Ramps or Equivalent.**

Total Cost: \$ 3200.00
