Access Compliance Report Public Rights-of-Way (Curb Ramps)

Intersection ID: 10037314 Main Street: SARDIS_RD Cross Street: N/A Location: NE

ADA ID: E0B43D4B9F70 Ramp Type: Directional1 Initial Pass/Fail: Fail Overall Compliance: No Severity Score: 12.5

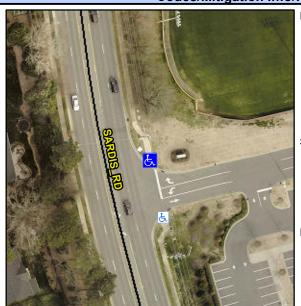
N/A No Ramp Slope (%) 11.5 Grade Break XSlope (%) Ramp XSlope (%) 0.5 Yes N/A Flare Type LT N/A N/A Flare Type RT N/A Flare Slope LT (%) N/A N/A Flare Slope RT (%) N/A Flare Traversable LT? N/A N/A Flare Traversable RT? N/A 0.0 N/A **DWS Provided?** Landing Length (in) N/A **DWS Contrast?** N/A Landing Width (in) 0.0 N/A Landing Slope (%) 0.0 N/A DWS Length (in) N/A 0.0 N/A DWS Full Width? Landing X Slope (%) N/A Landing Curb? (Y/N) N/A N/A DWS Offset LT (in) N/A Shared Landing? N/A N/A DWS Offset RT (in) N/A **Gutter Ponding?** 0.0 N/A Gutter Slope (%) N/A Gutter Lip Ht (in) 0.0 N/A Gutter X Slope (%) N/A Painted X Walk1? No Road Slope (%) To S X Walk 1 Direction Road X Slope (%) X Walk 1 Width (in) N/A Clear Space? X Walk 1 Slope (%) 3.0 N/A Clear Space to XWalk (in) X Walk 1 X Slope (%) 2.8 N/A Storm Grate/Utility Hazard? N/A Ramp inside XWalk1? N/A Storm Grate/Utility Type N/A N/A Any Obstructions? **Obstruction Type** Surface Condition? (G/P) Yes N/A N/A Curb Slope (%)

Possible Solutions:

Remove & Replace Entire Ramp.
