Intersection ID: 8795	Main Street: BANCROFT_ST	Cross Street: DOGWOOD_AV	Location:	SW
ADA ID: E0B9CC7C88DF	Ramp Type: Perp	Initial Pass/Fail: Fail	Overall Compliance: No	Severity Score: 10

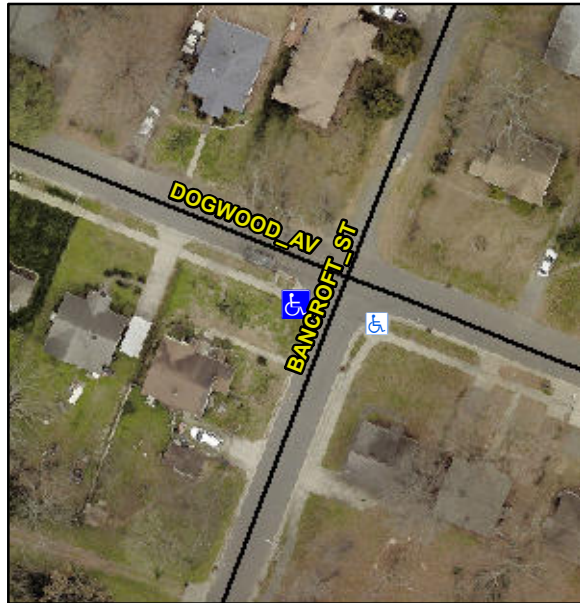
**Not Found, R304.5.1, R304.5.3**

Compliance	Description	Data	Compliance	Description	Data
N/A	Ramp Length (in)	60.5	Yes	Ramp Slope (%)	7.7
No	Ramp Width (in)	47.5	No	Ramp XSlope (%)	2.1
N/A	Flare Type LT	N/A	N/A	Flare Type RT	N/A
N/A	Flare Slope LT (%)	N/A	N/A	Flare Slope RT (%)	N/A
N/A	Flare Traversable LT?	N/A	N/A	Flare Traversable RT?	N/A
N/A	Landing Length (in)	N/A	N/A	DWS Provided?	N/A
N/A	Landing Width (in)	N/A	N/A	DWS Contrast?	N/A
N/A	Landing Slope (%)	N/A	N/A	DWS Length (in)	N/A
N/A	Landing X Slope (%)	N/A	N/A	DWS Full Width?	N/A
N/A	Landing Curb? (Y/N)	N/A	N/A	DWS Offset (in)	N/A
N/A	Shared Landing?	N/A			
N/A	Gutter Ponding?	N/A	N/A	Gutter Slope (%)	N/A
N/A	Gutter Lip Ht (in)	N/A	N/A	Gutter X Slope (%)	N/A
N/A	Painted X Walk1?	No	N/A	Painted X Walk2?	N/A
	X Walk 1 Direction	To SE		X Walk 2 Direction	N/A
N/A	X Walk 1 Width (in)	N/A	N/A	X Walk 2 Width (in)	N/A
	X Walk 1 Slope (%)	2.3		X Walk 2 Slope (%)	N/A
	X Walk 1 X Slope (%)	0.6		X Walk 2 X Slope (%)	N/A

N/A	Ramp inside XWalk1?	N/A	N/A	Ramp inside XWalk2?	N/A
	Road Slope (%)	N/A	N/A	Clear Space?	N/A
	Road X Slope (%)	N/A	N/A	Clear Space to XWalk (in)	N/A
N/A	Any Obstructions?	N/A	N/A	Storm Grate/Utility Hazard?	N/A
	Obstruction Type			Storm Grate/Utility Type	
		N/A			N/A
			Yes	Surface Condition? (G/P)	Good

### Possible Solutions:

### Remove & Replace Entire Ramp.
