Access Compliance Report

Public Rights-of-Way

(Curb Ramps)

Intersection ID: 12681	Main Street: PALOVERDE_LN	Cross Street: PENCE_RD	Location: NW
ADA ID: E0D10EBC537C	Ramp Type: Perp	Initial Pass/Fail: Fail	Overall Compliance: No
		Severity Score: 10

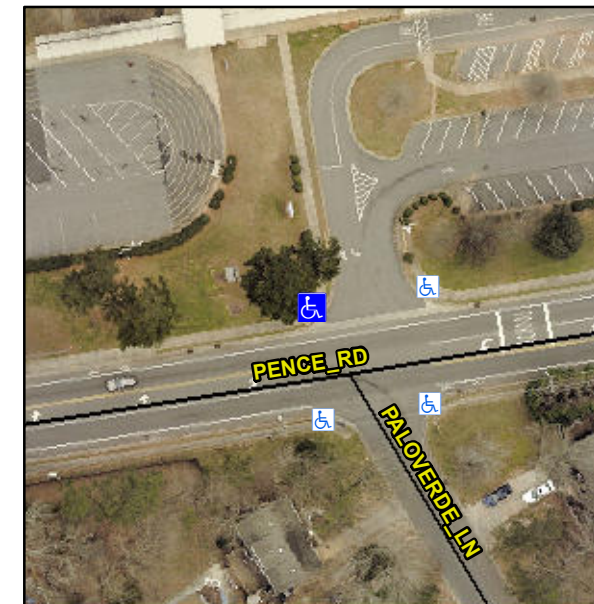
Not Found, R304.5.1

Compliance	Description	Data	Compliance	Description	Data
N/A	Ramp Length (in)	83.5	Yes	Ramp Slope (%)	6.8
No	Ramp Width (in)	40.0	Yes	Ramp XSlope (%)	2.8
N/A	Flare Type LT	N/A	N/A	Flare Type RT	N/A
N/A	Flare Slope LT (%)	N/A	N/A	Flare Slope RT (%)	N/A
N/A	Flare Traversable LT?	N/A	N/A	Flare Traversable RT?	N/A
N/A	Landing Length (in)	N/A	N/A	DWS Provided?	N/A
N/A	Landing Width (in)	N/A	N/A	DWS Contrast?	N/A
N/A	Landing Slope (%)	N/A	N/A	DWS Length (in)	N/A
N/A	Landing X Slope (%)	N/A	N/A	DWS Full Width?	N/A
N/A	Landing Curb? (Y/N)	N/A	N/A	DWS Offset (in)	N/A
N/A	Shared Landing?	N/A			
N/A	Gutter Ponding?	N/A	N/A	Gutter Slope (%)	N/A
N/A	Gutter Lip Ht (in)	N/A	N/A	Gutter X Slope (%)	N/A
N/A	Painted X Walk1?	No	N/A	Painted X Walk2?	N/A
	X Walk 1 Direction	To S		X Walk 2 Direction	N/A
N/A	X Walk 1 Width (in)	N/A	N/A	X Walk 2 Width (in)	N/A
	X Walk 1 Slope (%)	1.4		X Walk 2 Slope (%)	N/A
	X Walk 1 X Slope (%)	3.8		X Walk 2 X Slope (%)	N/A

N/A	Ramp inside XWalk1?	N/A	N/A	Ramp inside XWalk2?	N/A
	Road Slope (%)	N/A	N/A	Clear Space?	N/A
	Road X Slope (%)	N/A	N/A	Clear Space to XWalk (in)	N/A
N/A	Any Obstructions?	N/A	N/A	Storm Grate/Utility Hazard?	N/A
	Obstruction Type			Storm Grate/Utility Type	
		N/A			N/A
			Yes	Surface Condition? (G/P)	Good

Remove & Replace Entire Ramp.
