Access Compliance Report

Public Rights-of-Way

(Curb Ramps)

Intersection ID: 13575	Main Street: KENHILL_DR	Cross Street: MARKLAND_DR	Location: NW
ADA ID: E0D68F217EF9	Ramp Type: Directional1	Initial Pass/Fail: Fail	Overall Compliance: No
Severity Score: 21.25			
Codes/Mitigation Info/Possible Solution		Field Measurements/Component Compliance

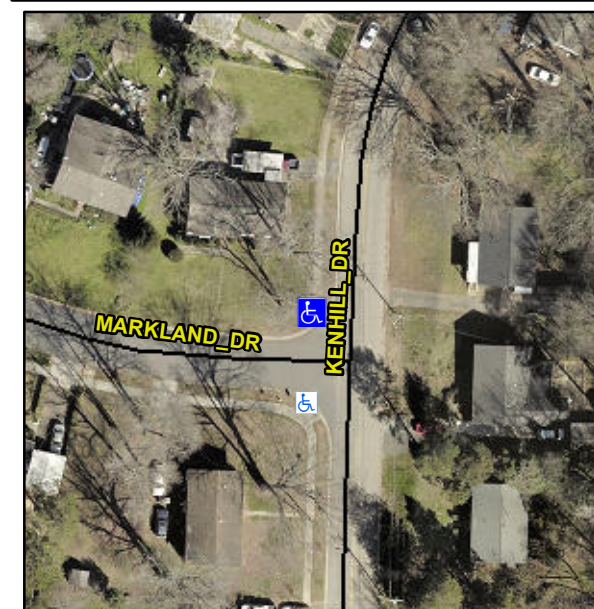
Compliance	Description	Data	Compliance	Description	Data
N/A	Ramp Length (in)	45.0	N/A	Grade Break?	N/A
No	Ramp Width (in)	44.0	N/A	Grade Break Slope (%)	0.0
No	Ramp Slope (%)	8.8	N/A	Grade Break XSlope (%)	0.0
Yes	Ramp XSlope (%)	0.5			
N/A	Flare Type LT	N/A	N/A	Flare Type RT	N/A
N/A	Flare Slope LT (%)	N/A	N/A	Flare Slope RT (%)	0.0
N/A	Flare Traversable LT?	N/A	N/A	Flare Traversable RT?	N/A
N/A	Landing Length (in)	0.0	N/A	DWS Provided?	N/A
N/A	Landing Width (in)	0.0	N/A	DWS Contrast?	N/A
N/A	Landing Slope (%)	0.0	N/A	DWS Length (in)	N/A
N/A	Landing X Slope (%)	0.0	N/A	DWS Full Width?	N/A
N/A	Landing Curb? (Y/N)	N/A	N/A	DWS Offset LT (in)	N/A
N/A	Shared Landing?	N/A	N/A	DWS Offset RT (in)	N/A
N/A	Gutter Ponding?	0.0	N/A	Gutter Slope (%)	N/A
N/A	Gutter Lip Ht (in)	0.0	N/A	Gutter X Slope (%)	N/A
N/A	Painted X Walk1?	No		Road Slope (%)	2.4
	X Walk 1 Direction	To SE		Road X Slope (%)	9.6
	X Walk 1 Width (in)	N/A		Clear Space?	N/A

X Walk 1 Slope (%)	2.4	N/A	Clear Space to XWalk (in)	N/A
	X Walk 1 X Slope (%)	9.6	N/A	Storm Grate/Utility Hazard?	N/A
N/A	Ramp inside XWalk1?	N/A		Storm Grate/Utility Type	
N/A	Any Obstructions?	N/A			N/A
	Obstruction Type		Yes	Surface Condition? (G/P)	Good
			N/A	Curb Slope (%)	7.3

Possible Solutions:

Remove & Replace Entire Ramp.
