# Access Compliance Report

## Public Rights-of-Way

### (Curb Ramps)

| Intersection ID: 8932 | Main Street: JENNINGS_ST | Cross Street: N/A | Location: SW |

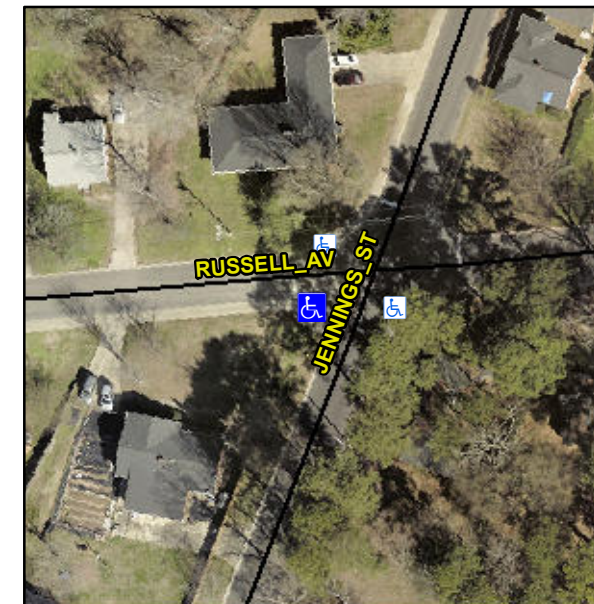
| ADA ID: E0E7B1AD56E8 | Ramp Type: PerpDiag | Initial Pass/Fail: Fail | Overall Compliance: No |

**Not Found, R304.2.2, R304.5.3**

| Compliance | Description | Data | Compliance | Description | Data |
|---|---|---|---|---|---|
| N/A | Ramp Length (in) | 66.0 | No | Ramp Slope (%) | 10.9 |
| Yes | Ramp Width (in) | 57.0 | No | Ramp XSlope (%) | 4.5 |

**Remove & Replace Curb Ramp With Two New Directional Ramps or Equivalent.**
