Access Compliance Report

Public Rights-of-Way

(Curb Ramps)

Intersection ID: 8515	Main Street: ATANDO_AV	Cross Street: STATESVILLE_AV	Location: NW
ADA ID: E0EF069D4384	Ramp Type: Para	Initial Pass/Fail: Pass	Overall Compliance: No
		Severity Score: 0

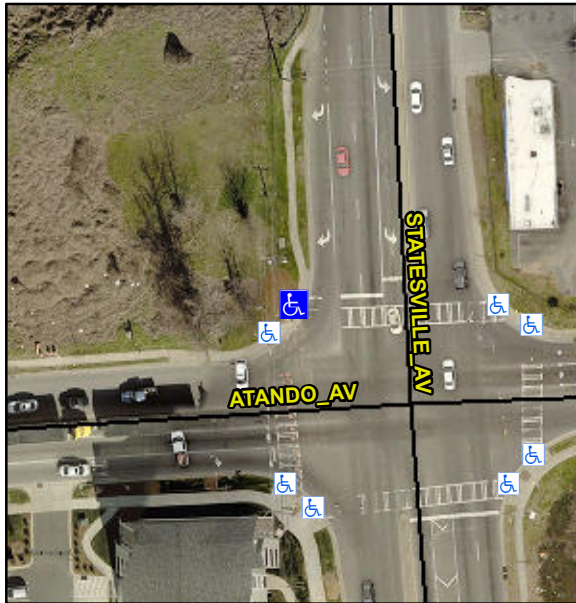
Not Found, R304.2.1

Compliance	Description	Data	Compliance	Description	Data
N/A	Ramp Length LT (in)	64.0	N/A	Ramp Length RT (in)	60.0
Yes	Ramp Width LT (in)	60.0	Yes	Ramp Width RT (in)	60.0
Yes	Ramp Slope LT (%)	7.2	Yes	Ramp Slope RT (%)	7.1
Yes	Ramp XSlope LT (%)	1.2	Yes	Ramp XSlope RT (%)	0.0
Yes	Landing Length (in)	60.0	Yes	DWS Provided?	Yes
No	Landing Width (in)	44.0	Yes	DWS Contrast?	Yes
Yes	Landing Slope (%)	1.8	Yes	DWS Length (in)	24.0
Yes	Landing X Slope (%)	1.3	Yes	DWS Full Width?	Yes
N/A	Landing Curb? (Y/N)	No	Yes	DWS Offset (in)	1.5
N/A	Shared Landing?	No			
Yes	Gutter Ponding?	No	Yes	Gutter Slope (%)	3.4
Yes	Gutter Lip Ht (in)	0.0	Yes	Gutter X Slope (%)	1.3
N/A	Painted X Walk1?	No	N/A	Painted X Walk2?	N/A
	X Walk 1 Direction	To E		X Walk 2 Direction	N/A
N/A	X Walk 1 Width (in)	N/A	N/A	X Walk 2 Width (in)	N/A
	X Walk 1 Slope (%)	1.8		X Walk 2 Slope (%)	N/A
	X Walk 1 X Slope (%)	0.7		X Walk 2 X Slope (%)	N/A
N/A	Ramp inside XWalk1?	N/A	N/A	Ramp inside XWalk2?	N/A

Road Slope (%)	N/A	N/A	Clear Space?	Yes
	Road X Slope (%)	N/A	N/A	Clear Space to XWalk (in)	N/A
Yes	Any Obstructions?	No	Yes	Storm Grate/Utility Hazard?	No
	Obstruction Type			Storm Grate/Utility Type	
		N/A			N/A
			Yes	Surface Condition? (G/P)	Good
			Replace	Curb Slope (%)	10.7

Possible Solutions:

Remove & Replace Entire Ramp.
