# Access Compliance Report

## Public Rights-of-Way

### (Curb Ramps)

Intersection ID: 44218	Main Street: ATHERTON_MILL_RD	Cross Street: ROZZELLES_LANDING_DR	Location: SE
ADA ID: E0F4FB652D17	Ramp Type: PerpDiag	Initial Pass/Fail: Fail	Overall Compliance: No
Codes/Mitigation Info/Possible Solution		Field Measurements/Component Compliance	
Severity Score: 8.75

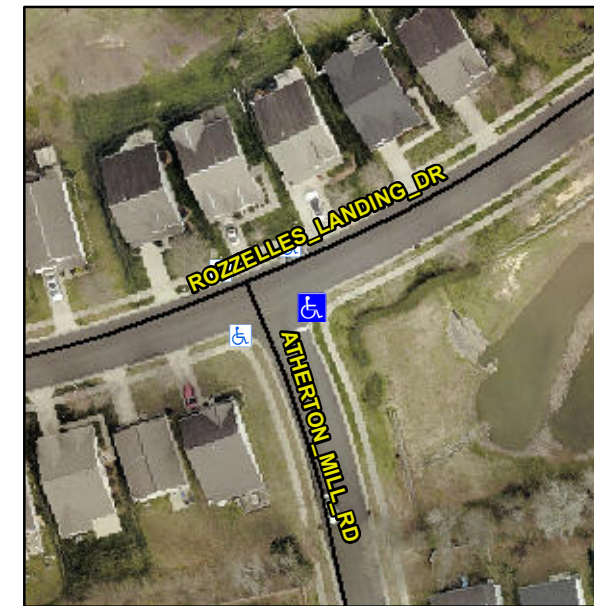
Compliance	Description	Data	Compliance	Description	Data
N/A	Ramp Length (in)	52.0	Yes	Ramp Slope (%)	5.2
No	Ramp Width (in)	38.0	Yes	Ramp XSlope (%)	0.2
N/A	Flare Type LT	N/A	N/A	Flare Type RT	N/A
N/A	Flare Slope LT (%)	N/A	N/A	Flare Slope RT (%)	N/A
N/A	Flare Traversable LT?	N/A	N/A	Flare Traversable RT?	N/A
N/A	Landing Length (in)	N/A	N/A	DWS Provided?	N/A
N/A	Landing Width (in)	N/A	N/A	DWS Contrast?	N/A
N/A	Landing Slope (%)	N/A	N/A	DWS Length (in)	N/A
N/A	Landing X Slope (%)	N/A	N/A	DWS Full Width?	N/A
N/A	Landing Curb? (Y/N)	N/A	N/A	DWS Offset (in)	N/A
N/A	Shared Landing?	N/A			
N/A	Gutter Ponding?	N/A	N/A	Gutter Slope (%)	N/A
N/A	Gutter Lip Ht (in)	N/A	N/A	Gutter X Slope (%)	N/A
N/A	Painted X Walk1?	No	N/A	Painted X Walk2?	No
	X Walk 1 Direction	To N		X Walk 2 Direction	To W
N/A	X Walk 1 Width (in)	N/A	N/A	X Walk 2 Width (in)	N/A
	X Walk 1 Slope (%)	4.5		X Walk 2 Slope (%)	3.7
	X Walk 1 X Slope (%)	2.9		X Walk 2 X Slope (%)	3.5

N/A	Ramp inside XWalk1?	N/A	N/A	Ramp inside XWalk2?	N/A
	Road Slope (%)	1.0	N/A	Clear Space?	N/A
	Road X Slope (%)	5.7	N/A	Clear Space to XWalk (in)	N/A
N/A	Any Obstructions?	N/A	N/A	Storm Grate/Utility Hazard?	N/A
	Obstruction Type			Storm Grate/Utility Type	
		N/A			N/A
			Yes	Surface Condition? (G/P)	Good

**Remove & Replace Curb Ramp With Two New Directional Ramps or Equivalent.**
