# Access Compliance Report

## Public Rights-of-Way

### (Curb Ramps)

| Intersection ID: 27495 | Main Street: BALLANTYNE COMMONS PY | Cross Street: NORTH COMMUNITY HOUSE RD | Location: SW |

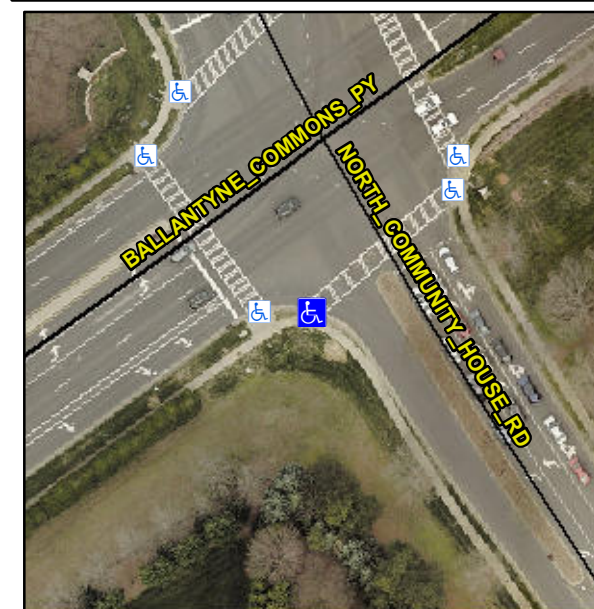
| ADA ID: E0FAE05C4D91 | Ramp Type: Perp | Initial Pass/Fail: Fail | Overall Compliance: No |
| Severity Score: 33.75 | | | |

**Not Found, R304.5.1, R304.5.3**

| Compliance | Description | Data | Compliance | Description | Data |
|---|---|---|---|---|---|
| N/A | Ramp Length (in) | 25.0 | Yes | Ramp Slope (%) | 5.5 |
| No | Ramp Width (in) | 47.0 | No | Ramp XSlope (%) | 7.5 |

Possible Solutions:

**Remove & Replace Entire Ramp.**

Total Cost: \$ 1850.00
