# Access Compliance Report

## Public Rights-of-Way

### (Curb Ramps)

Intersection ID: 3448 Main Street: W W T HARRIS BV TO I-77 RA SB Street: I-77 TO W W T HARRIS BV RA SB Location: NE

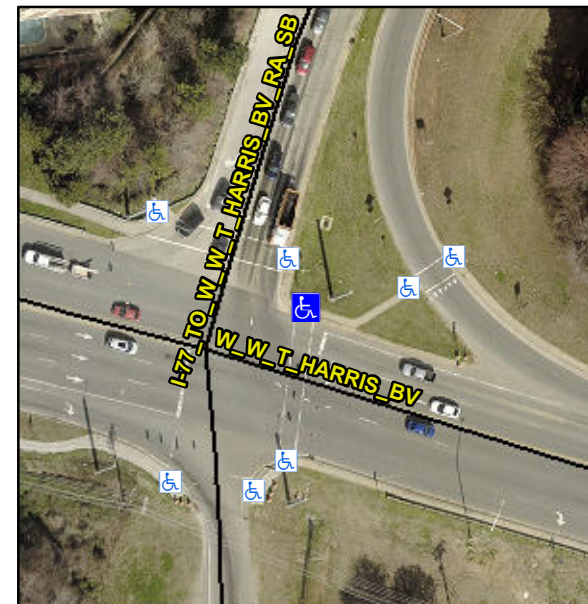
ADA ID: E0FF296013D6 Ramp Type: Para Initial Pass/Fail: Fail Overall Compliance: No Severity Score: 12.5

Compliance	Description	Data	Compliance	Description	Data
N/A	Ramp Length LT (in)	72.0	N/A	Ramp Length RT (in)	72.0
Yes	Ramp Width LT (in)	60.0	Yes	Ramp Width RT (in)	60.0
Yes	Ramp Slope LT (%)	7.8	No	Ramp Slope RT (%)	9.2
Yes	Ramp XSlope LT (%)	1.2	Yes	Ramp XSlope RT (%)	0.9
N/A	Landing Length (in)	N/A	N/A	DWS Provided?	N/A
N/A	Landing Width (in)	N/A	N/A	DWS Contrast?	N/A
N/A	Landing Slope (%)	N/A	N/A	DWS Length (in)	N/A
N/A	Landing X Slope (%)	N/A	N/A	DWS Full Width?	N/A
N/A	Landing Curb? (Y/N)	N/A	N/A	DWS Offset (in)	N/A
N/A	Shared Landing?	N/A			
N/A	Gutter Ponding?	N/A	N/A	Gutter Slope (%)	N/A
N/A	Gutter Lip Ht (in)	N/A	N/A	Gutter X Slope (%)	N/A
N/A	Painted X Walk1?	Yes	N/A	Painted X Walk2?	N/A
	X Walk 1 Direction	To S		X Walk 2 Direction	N/A
N/A	X Walk 1 Width (in)	118.0	N/A	X Walk 2 Width (in)	N/A
	X Walk 1 Slope (%)	4.3		X Walk 2 Slope (%)	N/A
	X Walk 1 X Slope (%)	0.0		X Walk 2 X Slope (%)	N/A
N/A	Ramp inside XWalk1?	Yes	N/A	Ramp inside XWalk2?	N/A

Road Slope (%)	N/A	N/A	Clear Space?	N/A
	Road X Slope (%)	N/A	N/A	Clear Space to XWalk (in)	N/A
N/A	Any Obstructions?	N/A	N/A	Storm Grate/Utility Hazard?	N/A
	Obstruction Type			Storm Grate/Utility Type	
		N/A			N/A
			Yes	Surface Condition? (G/P)	Good
			N/A	Curb Slope (%)	3.7

**Remove & Replace Entire Ramp.**
