# Access Compliance Report

## Public Rights-of-Way

### (Curb Ramps)

Intersection ID: 50609	Main Street: DOWNY_BIRCH_RD	Cross Street: PADDLE_OAK_RD	Location: SW
ADA ID: E1104DBEBDFA	Ramp Type: Perp	Initial Pass/Fail: Fail	Overall Compliance: No
Severity Score: 21.25			
Codes/Mitigation Info/Possible Solution		Field Measurements/Component Compliance

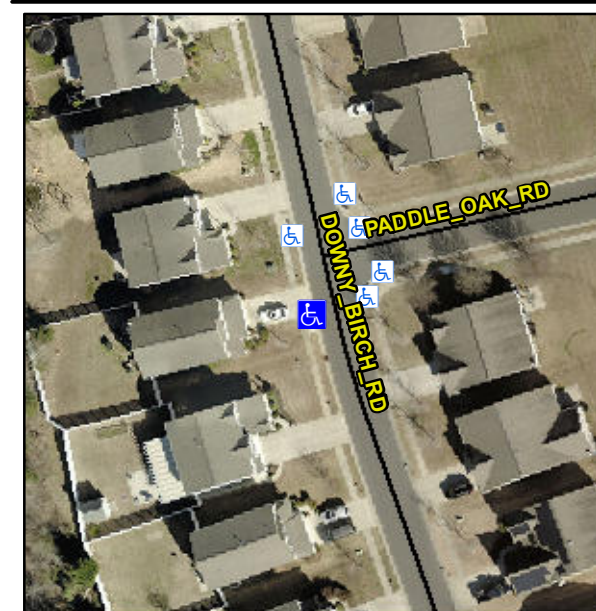
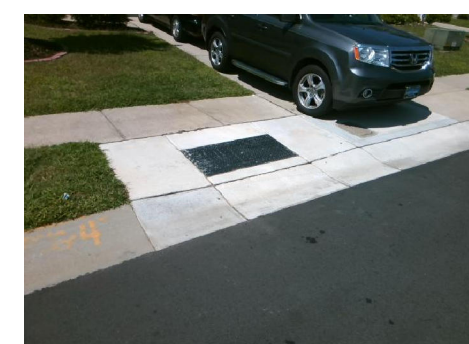
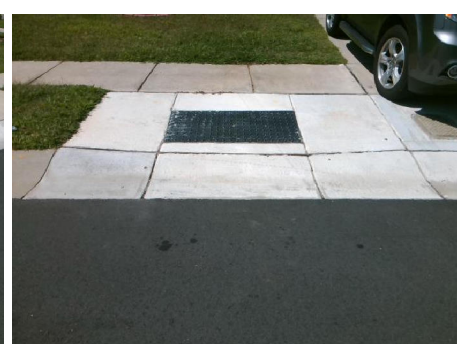
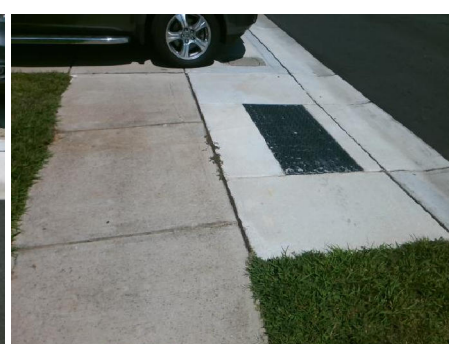
**Not Found, R304.5.1, R304.2.2**

Compliance	Description	Data	Compliance	Description	Data
N/A	Ramp Length (in)	47.5	No	Ramp Slope (%)	10.2
No	Ramp Width (in)	47.5	Yes	Ramp XSlope (%)	0.3
N/A	Flare Type LT	N/A	N/A	Flare Type RT	N/A
N/A	Flare Slope LT (%)	N/A	N/A	Flare Slope RT (%)	N/A
N/A	Flare Traversable LT?	N/A	N/A	Flare Traversable RT?	N/A
N/A	Landing Length (in)	N/A	N/A	DWS Provided?	N/A
N/A	Landing Width (in)	N/A	N/A	DWS Contrast?	N/A
N/A	Landing Slope (%)	N/A	N/A	DWS Length (in)	N/A
N/A	Landing X Slope (%)	N/A	N/A	DWS Full Width?	N/A
N/A	Landing Curb? (Y/N)	N/A	N/A	DWS Offset (in)	N/A
N/A	Shared Landing?	N/A			
N/A	Gutter Ponding?	N/A	N/A	Gutter Slope (%)	N/A
N/A	Gutter Lip Ht (in)	N/A	N/A	Gutter X Slope (%)	N/A
N/A	Painted X Walk1?	No	N/A	Painted X Walk2?	N/A
	X Walk 1 Direction	To E		X Walk 2 Direction	N/A
N/A	X Walk 1 Width (in)	N/A	N/A	X Walk 2 Width (in)	N/A
	X Walk 1 Slope (%)	3.1		X Walk 2 Slope (%)	N/A
	X Walk 1 X Slope (%)	0.3		X Walk 2 X Slope (%)	N/A

N/A	Ramp inside XWalk1?	N/A	N/A	Ramp inside XWalk2?	N/A
	Road Slope (%)	N/A	N/A	Clear Space?	N/A
	Road X Slope (%)	N/A	N/A	Clear Space to XWalk (in)	N/A
N/A	Any Obstructions?	N/A	N/A	Storm Grate/Utility Hazard?	N/A
	Obstruction Type			Storm Grate/Utility Type	
		N/A			N/A
		Yes		Surface Condition? (G/P)	Good

**Remove & Replace Entire Ramp.**
