Access Compliance Report

Public Rights-of-Way

(Curb Ramps)

Intersection ID: 30169	Main Street: BUTTONBUSH_CT	Cross Street: SLATER_RIDGE_DR	Location: SW
ADA ID: E11692E2992C	Ramp Type: PerpDiag	Initial Pass/Fail: Fail	Overall Compliance: No
Severity Score: 21.25			
Codes/Mitigation Info/Possible Solution		Field Measurements/Component Compliance

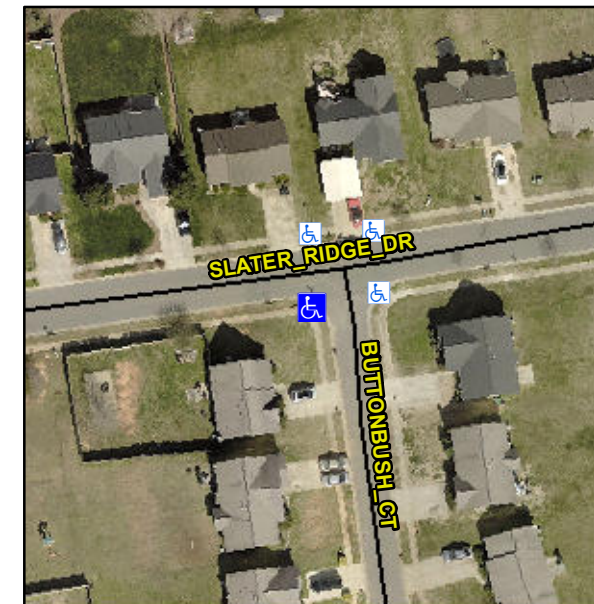
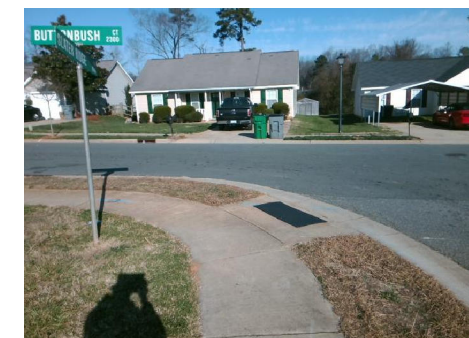
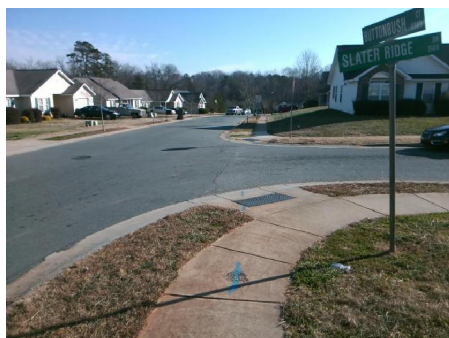
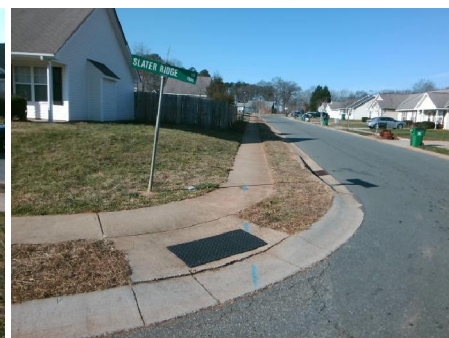
R304.5.1, R304.5.3

Compliance	Description	Data	Compliance	Description	Data
N/A	Ramp Length (in)	47.5	Yes	Ramp Slope (%)	6.5
No	Ramp Width (in)	43.0	No	Ramp XSlope (%)	5.1
N/A	Flare Type LT	N/A	N/A	Flare Type RT	N/A
N/A	Flare Slope LT (%)	N/A	N/A	Flare Slope RT (%)	N/A
N/A	Flare Traversable LT?	N/A	N/A	Flare Traversable RT?	N/A
N/A	Landing Length (in)	N/A	N/A	DWS Provided?	N/A
N/A	Landing Width (in)	N/A	N/A	DWS Contrast?	N/A
N/A	Landing Slope (%)	N/A	N/A	DWS Length (in)	N/A
N/A	Landing X Slope (%)	N/A	N/A	DWS Full Width?	N/A
N/A	Landing Curb? (Y/N)	N/A	N/A	DWS Offset (in)	N/A
N/A	Shared Landing?	N/A			
N/A	Gutter Ponding?	N/A	N/A	Gutter Slope (%)	N/A
N/A	Gutter Lip Ht (in)	1.0	N/A	Gutter X Slope (%)	N/A
N/A	Painted X Walk1?	No	N/A	Painted X Walk2?	No
	X Walk 1 Direction	To E		X Walk 2 Direction	To N
N/A	X Walk 1 Width (in)	N/A	N/A	X Walk 2 Width (in)	N/A
	X Walk 1 Slope (%)	1.6		X Walk 2 Slope (%)	0.5
	X Walk 1 X Slope (%)	1.1		X Walk 2 X Slope (%)	1.5

N/A	Ramp inside XWalk1?	N/A	N/A	Ramp inside XWalk2?	N/A
	Road Slope (%)	2.6	N/A	Clear Space?	N/A
	Road X Slope (%)	0.6	N/A	Clear Space to XWalk (in)	N/A
N/A	Any Obstructions?	N/A	N/A	Storm Grate/Utility Hazard?	N/A
	Obstruction Type			Storm Grate/Utility Type	
		N/A			N/A
			Yes	Surface Condition? (G/P)	Good

Remove & Replace Curb Ramp With Two New Directional Ramps or Equivalent.
