Access Compliance Report Public Rights-of-Way (Curb Ramps)

Intersection ID: 27575 Main Street: FAWN_HILL_RD **Cross Street: FOX HEDGE RD** Location: SE **ADA ID: E11E377ABA77** Ramp Type: BlendTrans2 Initial Pass/Fail: Pass **Overall Compliance: No Severity Score:**

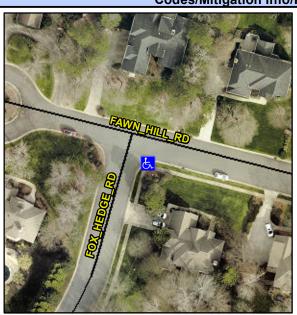
Field Measurements/Component Compliance					
Compliance Description		Data	Compliance Description		Data
N/A	Ramp Length (in)	60.0	Yes	BlendTrans Slope (%)	1.4
Yes	Ramp Width (in)	48.0	Yes	BlendTrans XSlope (%)	0.0
N/A	Flare Type LT	Sloped	N/A	Flare Type RT	Sloped
N/A	Flare Slope LT (%)	11.9	Yes	Flare Slope RT (%)	3.2
N/A	Flare Traversable LT?	No	N/A	Flare Traversable RT?	Yes
N/A	Landing Length (in)	N/A	Yes	DWS Provided?	Yes
N/A	Landing Width (in)	N/A	Yes	DWS Contrast?	Yes
N/A	Landing Slope (%)	N/A	Yes	DWS Length (in)	24.0
N/A	Landing X Slope (%)	N/A	Yes	DWS Full Width?	Yes
N/A	Landing Curb? (Y/N)	No	No	DWS Offset (in)	7.0
N/A	Shared Landing?	No			
Yes	Gutter Ponding?	No	Yes	Gutter Slope (%)	4.9
Yes	Gutter Lip Ht (in)	0.0	Yes	Gutter X Slope (%)	1.5
N/A	Painted X Walk1?	No	N/A	Painted X Walk2?	No
	X Walk 1 Direction	To N		X Walk 2 Direction	To W
	X Walk 1 Width (in)	N/A		X Walk 2 Width (in)	N/A
	X Walk 1 Slope (%)	4.4		X Walk 2 Slope (%)	0.3

X Walk 1 X Slope (%)	0.7		X Walk 2 X Slope (%)	4.2
N/A	Ramp inside XWalk1?	N/A	N/A	Ramp inside XWalk2?	N/A
	Road Slope (%)	0.9		Clear Space?	Yes
	Road X Slope (%)	3.3	N/A	Clear Space to XWalk (in)	N/A
Yes	Any Obstructions?	No	Yes	Storm Grate/Utility Hazard?	No
	Obstruction Type			Storm Grate/Utility Type	
		N/A			N/A
			Yes	Surface Condition? (G/P)	Good
GIV.			No	Curb Slope (%)	7.4

FAWN HILL RD None **FOX HEDGE RD** StopSign Possible Solutions: Remove & Replace Curb Ramp With Two New Directional Ramps or Equivalent. Surveyor Notes: N/A PROW/ADA: Not Found, R305.2
