Access Compliance Report

Public Rights-of-Way

(Curb Ramps)

Intersection ID: 18011	Main Street: PARK_RD	Cross Street: HEATHER_LN	Location: NE
ADA ID: E11F4985D9EB	Ramp Type: Perp	Initial Pass/Fail: Fail	Overall Compliance: No
Severity Score: 8.75			
Codes/Mitigation Info/Possible Solution		Field Measurements/Component Compliance

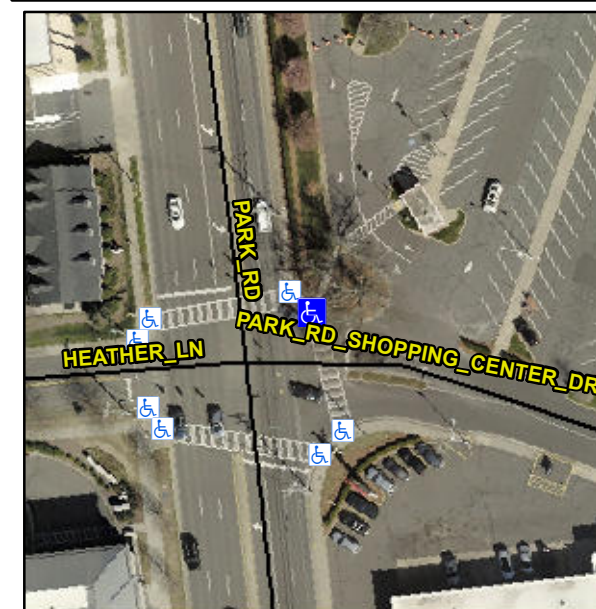
Not Found, R304.5.1

Compliance	Description	Data	Compliance	Description	Data
N/A	Ramp Length (in)	60.0	Yes	Ramp Slope (%)	5.7
No	Ramp Width (in)	46.5	Yes	Ramp XSlope (%)	0.3
N/A	Flare Type LT	N/A	N/A	Flare Type RT	N/A
N/A	Flare Slope LT (%)	N/A	N/A	Flare Slope RT (%)	N/A
N/A	Flare Traversable LT?	N/A	N/A	Flare Traversable RT?	N/A
N/A	Landing Length (in)	N/A	N/A	DWS Provided?	N/A
N/A	Landing Width (in)	N/A	N/A	DWS Contrast?	N/A
N/A	Landing Slope (%)	N/A	N/A	DWS Length (in)	N/A
N/A	Landing X Slope (%)	N/A	N/A	DWS Full Width?	N/A
N/A	Landing Curb? (Y/N)	N/A	N/A	DWS Offset (in)	N/A
N/A	Shared Landing?	N/A			
N/A	Gutter Ponding?	N/A	N/A	Gutter Slope (%)	N/A
N/A	Gutter Lip Ht (in)	N/A	N/A	Gutter X Slope (%)	N/A
N/A	Painted X Walk1?	Yes	N/A	Painted X Walk2?	N/A
	X Walk 1 Direction	To S		X Walk 2 Direction	N/A
N/A	X Walk 1 Width (in)	106.0	N/A	X Walk 2 Width (in)	N/A
	X Walk 1 Slope (%)	0.9		X Walk 2 Slope (%)	N/A
	X Walk 1 X Slope (%)	1.8		X Walk 2 X Slope (%)	N/A

N/A	Ramp inside XWalk1?	Yes	N/A	Ramp inside XWalk2?	N/A
	Road Slope (%)	N/A	N/A	Clear Space?	N/A
	Road X Slope (%)	N/A	N/A	Clear Space to XWalk (in)	N/A
N/A	Any Obstructions?	N/A	N/A	Storm Grate/Utility Hazard?	N/A
	Obstruction Type			Storm Grate/Utility Type	
		N/A			N/A
			Yes	Surface Condition? (G/P)	Good

Remove & Replace Entire Ramp.

Total Cost: \$ 1850.00
