# Access Compliance Report

## Public Rights-of-Way

| Intersection ID: N/A | Main Street: UNION_PACIFIC_AV | Cross Street: BELLE_VERNON_AV | Location: W |
| ADA ID: E138FD152EA0 | Ramp Type: PerpDiag | Initial Pass/Fail: Fail | Overall Compliance: No |

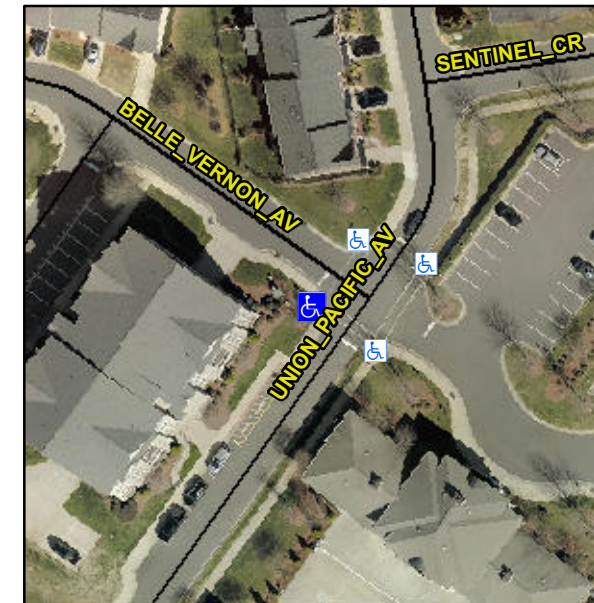
| | | | Severity Score: 13.75 |

**Not Found, R304.2.2, R304.5.3**

| Compliance | Description | Data | Compliance | Description | Data |
|---|---|---|---|---|---|
| N/A | Ramp Length (in) | 59.0 | No | Ramp Slope (%) | 10.7 |
| Yes | Ramp Width (in) | 48.5 | No | Ramp XSlope (%) | 2.5 |

**Remove & Replace Curb Ramp With Two New Directional Ramps or Equivalent.**

Total Cost: \$ 3200.00
