Access Compliance Report

Public Rights-of-Way

(Curb Ramps)

Intersection ID: 26975	Main Street: SOUTH_HALL_DR	Cross Street: WARWICKSHIRE_LN	Location: SE
ADA ID: E157E81E90E2	Ramp Type: PerpDiag	Initial Pass/Fail: Fail	Overall Compliance: No
		Severity Score: 8.75

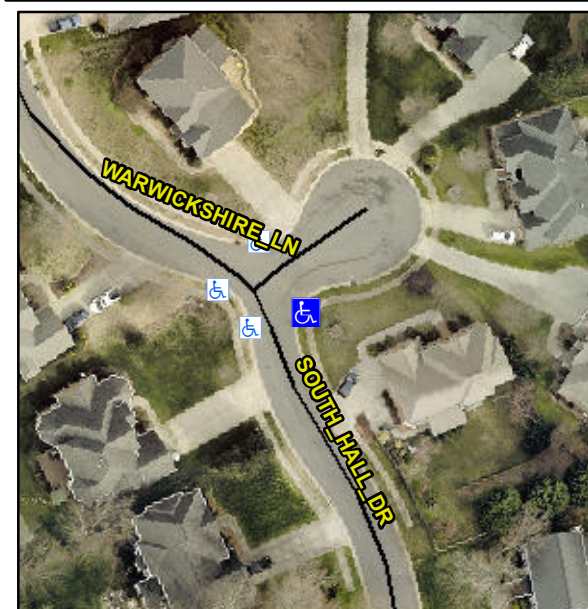
Not Found, R304.5.1

Compliance	Description	Data	Compliance	Description	Data
N/A	Ramp Length (in)	49.5	Yes	Ramp Slope (%)	7.3
No	Ramp Width (in)	37.5	Yes	Ramp XSlope (%)	0.5
N/A	Flare Type LT	N/A	N/A	Flare Type RT	N/A
N/A	Flare Slope LT (%)	N/A	N/A	Flare Slope RT (%)	N/A
N/A	Flare Traversable LT?	N/A	N/A	Flare Traversable RT?	N/A
N/A	Landing Length (in)	N/A	N/A	DWS Provided?	N/A
N/A	Landing Width (in)	N/A	N/A	DWS Contrast?	N/A
N/A	Landing Slope (%)	N/A	N/A	DWS Length (in)	N/A
N/A	Landing X Slope (%)	N/A	N/A	DWS Full Width?	N/A
N/A	Landing Curb? (Y/N)	N/A	N/A	DWS Offset (in)	N/A
N/A	Shared Landing?	N/A			
N/A	Gutter Ponding?	N/A	N/A	Gutter Slope (%)	N/A
N/A	Gutter Lip Ht (in)	N/A	N/A	Gutter X Slope (%)	N/A
N/A	Painted X Walk1?	No	N/A	Painted X Walk2?	No
	X Walk 1 Direction	To N		X Walk 2 Direction	To W
N/A	X Walk 1 Width (in)	N/A	N/A	X Walk 2 Width (in)	N/A
	X Walk 1 Slope (%)	3.9		X Walk 2 Slope (%)	1.3
	X Walk 1 X Slope (%)	2.3		X Walk 2 X Slope (%)	1.5

N/A	Ramp inside XWalk1?	N/A	N/A	Ramp inside XWalk2?	N/A
	Road Slope (%)	3.5	N/A	Clear Space?	N/A
	Road X Slope (%)	0.1	N/A	Clear Space to XWalk (in)	N/A
N/A	Any Obstructions?	N/A	N/A	Storm Grate/Utility Hazard?	N/A
	Obstruction Type			Storm Grate/Utility Type	
		N/A			N/A
			Yes	Surface Condition? (G/P)	Good

Remove & Replace Curb Ramp With Two New Directional Ramps or Equivalent.
