## **Access Compliance Report Public Rights-of-Way** (Curb Ramps)

Intersection ID: 10025569 Main Street: E W T HARRIS BV **Cross Street: N/A** Location: SE ADA ID: E16FCD115A5D Ramp Type: PerpDiag Initial Pass/Fail: Fail **Overall Compliance: No** Severity Score: 33.75

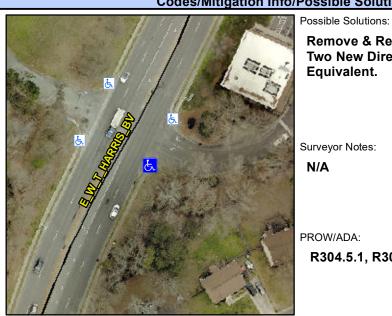
R304.5.1, R304.5.3

Field Measurements/Component Compliance							
Compliance Description		Data	Comp	liance Description	Data		
N/A	Ramp Length (in)	71.0	Yes	Ramp Slope (%)	7.5		
No	Ramp Width (in)	36.0	No	Ramp XSlope (%)	7.9		
N/A	Flare Type LT	N/A	N/A	Flare Type RT	N/A		
N/A	Flare Slope LT (%)	N/A	N/A	Flare Slope RT (%)	N/A		
N/A	Flare Traversable LT?	N/A	N/A	Flare Traversable RT?	N/A		
N/A	Landing Length (in)	N/A	N/A	DWS Provided?	N/A		
N/A	Landing Width (in)	N/A	N/A	DWS Contrast?	N/A		
N/A	Landing Slope (%)	N/A	N/A	DWS Length (in)	N/A		
N/A	Landing X Slope (%)	N/A	N/A	DWS Full Width?	N/A		
N/A	Landing Curb? (Y/N)	N/A	N/A	DWS Offset (in)	N/A		
N/A	Shared Landing?	N/A					
N/A	Gutter Ponding?	N/A	N/A	Gutter Slope (%)	N/A		
N/A	Gutter Lip Ht (in)	N/A	N/A	Gutter X Slope (%)	N/A		
N/A	Painted X Walk1?	No	N/A	Painted X Walk2?	No		
	X Walk 1 Direction	To NE		X Walk 2 Direction	To NW		
N/A	X Walk 1 Width (in)	N/A	N/A	X Walk 2 Width (in)	N/A

X Walk 1 Slope (%)	3.6		X Walk 2 Slope (%)	2.7		
	X Walk 1 X Slope (%)	1.2		X Walk 2 X Slope (%)	2.9		
N/A	Ramp inside XWalk1?	N/A	N/A	Ramp inside XWalk2?	N/A		
	Road Slope (%)	2.8	N/A	Clear Space?	N/A		
	Road X Slope (%)	0.1	N/A	Clear Space to XWalk (in)	N/A		
N/A	Any Obstructions?	N/A	N/A	Storm Grate/Utility Hazard?	N/A		
	Obstruction Type			Storm Grate/Utility Type			
		N/A			N/A		
			Yes	Surface Condition? (G/P)	Good

Remove & Replace Curb Ramp With **Two New Directional Ramps or** Equivalent.
