Access Compliance Report Public Rights-of-Way (Curb Ramps)

Intersection ID: 44420 Main Street: PROVIDENCE_PROMENADE_D&rds Street: PROVIDENCE_PROMENADE_DR_S Location: NE

ADA ID: E176A36CFF40 Ramp Type: Perp Initial Pass/Fail: Fail Overall Compliance: No Severity Score: 21.25

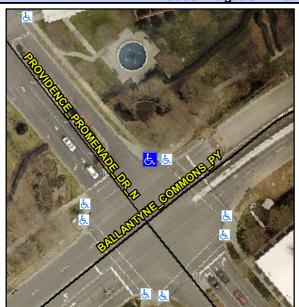
| Possible Solutions: | <u>c</u> | |
|---|---|--|
| R304.5.1, R304.2.2 | N | |

| Field Measurements/Component Compliance | | | | | | | |
|---|---|---|---|---|---|--|--|
| N/A | Ramp Length (in) | 72.0 | No | Ramp Slope (%) | 9.5 | | |
| No | Ramp Width (in) | 40.0 | Yes | Ramp XSlope (%) | 1.1 | | |

| Possible Solutions: | <u>c</u> | |
|---|---|--|
| Remove & Replace Entire Ramp. | | |
