Access Compliance Report

Public Rights-of-Way

(Curb Ramps)

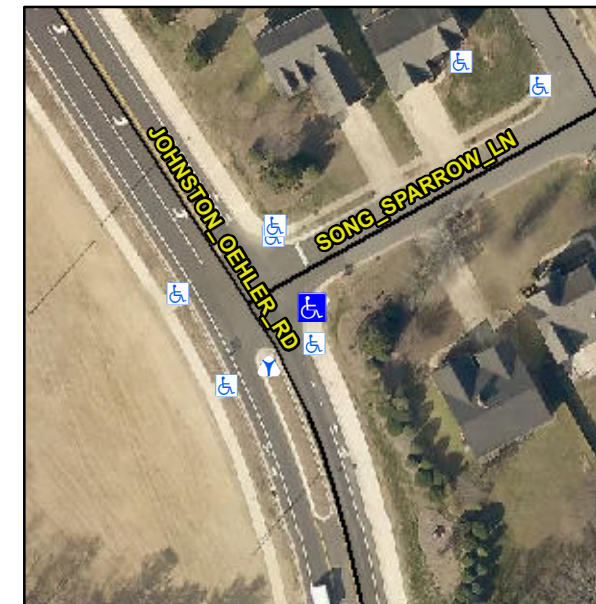
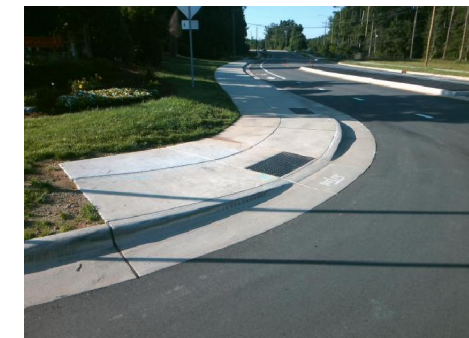
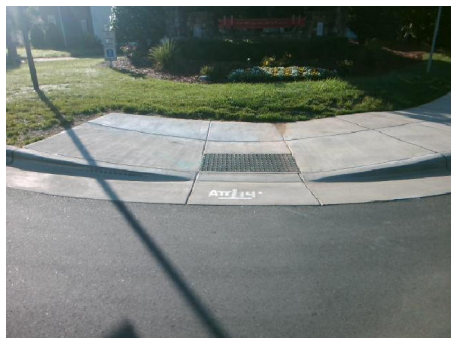
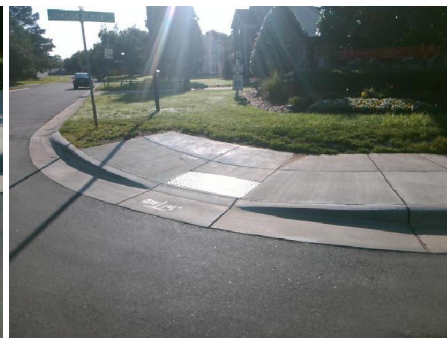
Intersection ID: 3180	Main Street: JOHNSTON_OEHLER_RD	Cross Street: SONG_SPARROW_LN	Location:	E
ADA ID: E179087FDFF7	Ramp Type: Combination1	Initial Pass/Fail: Fail	Overall Compliance: No	Severity Score: 22.5
Codes/Mitigation Info/Possible Solution		Field Measurements/Component Compliance

RT RP < 5%

**R304.5.1, R304.5.1, R304.2.2,
R304.5.3, R304.3.2**

Compliance	Description	Data	Compliance	Description	Data
N/A	Ramp Length LT (in)	69.5	N/A	Ramp Length RT (in)	45.5
No	Ramp Width LT (in)	42.5	No	Ramp Width RT (in)	41.5
No	Ramp Slope LT (%)	9.9	Yes	Ramp Slope RT (%)	4.6
No	Ramp XSlope LT (%)	2.2	Yes	Ramp XSlope RT (%)	1.3
N/A	Ramp Length (in)	48.0	No	Ramp Slope (%)	10.0
No	Ramp Width (in)	46.5	No	Ramp XSlope (%)	2.2
N/A	Flare Type LT	N/A	N/A	Flare Type RT	N/A
N/A	Flare Slope LT (%)	N/A	N/A	Flare Slope RT (%)	N/A
N/A	Flare Traversable LT?	N/A	N/A	Flare Traversable RT?	N/A
N/A	Landing Length (in)	N/A	N/A	DWS Provided?	N/A
N/A	Landing Width (in)	N/A	N/A	DWS Contrast?	N/A
N/A	Landing Slope (%)	N/A	N/A	DWS Length (in)	N/A
N/A	Landing X Slope (%)	N/A	N/A	DWS Full Width?	N/A
N/A	Landing Curb? (Y/N)	N/A	N/A	DWS Offset (in)	N/A
N/A	Shared Landing?	N/A			
N/A	Gutter Ponding?	N/A	N/A	Gutter Slope (%)	N/A
N/A	Gutter Lip Ht (in)	N/A	N/A	Gutter X Slope (%)	N/A
N/A	Painted X Walk1?	No	N/A	Painted X Walk2?	N/A

X Walk 1 Direction	To NW		X Walk 2 Direction	N/A
	X Walk 1 Width (in)	N/A		X Walk 2 Width (in)	N/A
	X Walk 1 Slope (%)	3.7		X Walk 2 Slope (%)	N/A
	X Walk 1 X Slope (%)	1.0		X Walk 2 X Slope (%)	N/A
N/A	Ramp inside XWalk1?	N/A	N/A	Ramp inside XWalk2?	N/A
	Road Slope (%)	N/A		Clear Space?	N/A
	Road X Slope (%)	N/A	N/A	Clear Space to XWalk (in)	N/A
			N/A	Any Obstruction?	N/A
				Obstruction Type	N/A
			N/A	Storm Grate/Utility Hazard?	N/A
				Storm Grate/Utility Type	N/A
			Yes	Surface Condition? (G/P)	Good
				Curb Slope (%)	N/A

Possible Solutions:

Remove & Replace Entire Ramp.

Total Cost: \$ 1800.00
