Access Compliance Report Public Rights-of-Way (Curb Ramps)

W Intersection ID: N/A Main Street: KENSAL GREEN DR Cross Street: WILTSHIRE MANOR DR Location: **Overall Compliance: No** 10 ADA ID: E17C51174D22 Ramp Type: Directional1 Initial Pass/Fail: Fail **Severity Score:**

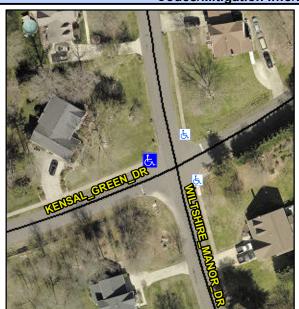
Possible Solution		Field Me
Possible Solutions:	Comp	liance Description
Remove & Replace Entire Ramp.	N/A	Ramp Length (in)
	No	Ramp Width (in)
	Yes	Ramp Slope (%)
	No	Ramp XSlope (%)
	N/A	Flare Type LT
	N/A	Flare Slope LT (%)
Surveyor Notes:	N/A	Flare Traversable L
N/A	N/A	Landing Length (in)
	N/A	Landing Width (in)
	N/A	Landing Slope (%)
	N/A	Landing X Slope (%
PROW/ADA:	N/A	Landing Curb? (Y/N
R304.5.1, R304.5.3	N/A	Shared Landing?
	N/A	Gutter Ponding?
	N/A	Gutter Lip Ht (in)
	N/A	Painted X Walk1?
		X Walk 1 Direction
		X Walk 1 Width (in)
		X Walk 1 Slope (%)
		X Walk 1 X Slope (%
