Intersection ID: 9779	Main Street: CAMPUS_ST	Cross Street: CEMETERY_ST	Location:	SE
ADA ID: E185B5C9C952	Ramp Type: PerpDiag	Initial Pass/Fail: Fail	Overall Compliance: No	Severity Score: 21.25

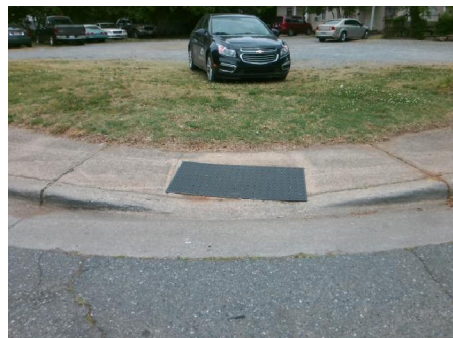
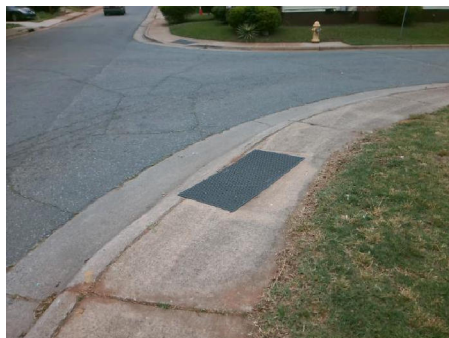
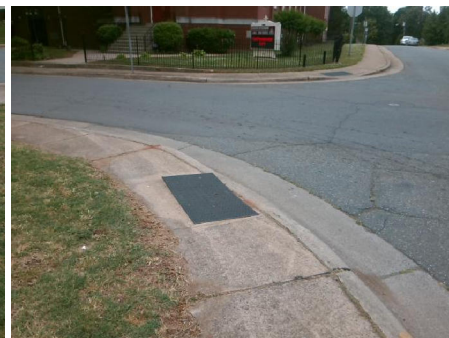
Not Found, R304.5.1, R304.2.2

Compliance	Description	Data	Compliance	Description	Data
N/A	Ramp Length (in)	42.0	No	Ramp Slope (%)	9.1
No	Ramp Width (in)	41.0	Yes	Ramp XSlope (%)	2.0
N/A	Flare Type LT	N/A	N/A	Flare Type RT	N/A
N/A	Flare Slope LT (%)	N/A	N/A	Flare Slope RT (%)	N/A
N/A	Flare Traversable LT?	N/A	N/A	Flare Traversable RT?	N/A
N/A	Landing Length (in)	N/A	N/A	DWS Provided?	N/A
N/A	Landing Width (in)	N/A	N/A	DWS Contrast?	N/A
N/A	Landing Slope (%)	N/A	N/A	DWS Length (in)	N/A
N/A	Landing X Slope (%)	N/A	N/A	DWS Full Width?	N/A
N/A	Landing Curb? (Y/N)	N/A	N/A	DWS Offset (in)	N/A
N/A	Shared Landing?	N/A			
N/A	Gutter Ponding?	N/A	N/A	Gutter Slope (%)	N/A
N/A	Gutter Lip Ht (in)	N/A	N/A	Gutter X Slope (%)	N/A
N/A	Painted X Walk1?	No	N/A	Painted X Walk2?	No
	X Walk 1 Direction	To N		X Walk 2 Direction	To W
N/A	X Walk 1 Width (in)	N/A	N/A	X Walk 2 Width (in)	N/A
	X Walk 1 Slope (%)	2.1		X Walk 2 Slope (%)	2.2
	X Walk 1 X Slope (%)	2.2		X Walk 2 X Slope (%)	2.9

N/A	Ramp inside XWalk1?	N/A	N/A	Ramp inside XWalk2?	N/A
	Road Slope (%)	2.5	N/A	Clear Space?	N/A
	Road X Slope (%)	2.4	N/A	Clear Space to XWalk (in)	N/A
N/A	Any Obstructions?	N/A	N/A	Storm Grate/Utility Hazard?	N/A
	Obstruction Type			Storm Grate/Utility Type	
		N/A			N/A
			Yes	Surface Condition? (G/P)	Good

Remove & Replace Curb Ramp With Two New Directional Ramps or Equivalent.
