# Access Compliance Report

## Public Rights-of-Way

### (Curb Ramps)

| Intersection ID: 15803 | Main Street: CLANTON_RD | Cross Street: DEWITT_LN | Location: SE |

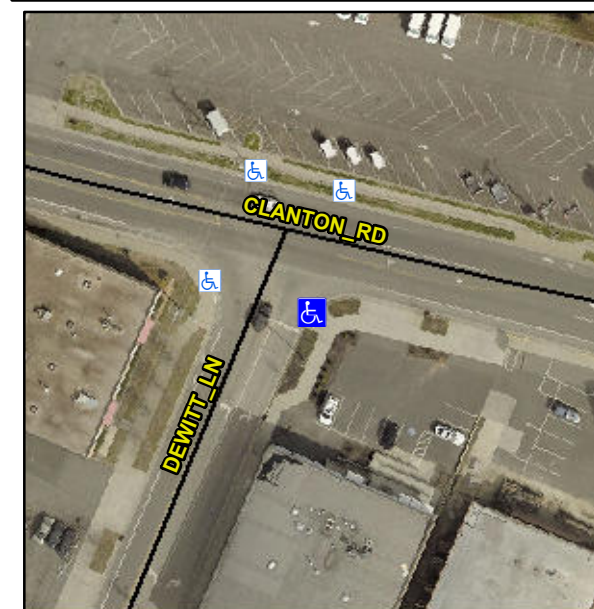
**Not Found, R304.5.1**

| Compliance | Description | Data | Compliance | Description | Data |
|---|---|---|---|---|---|
| N/A | Ramp Length (in) | 71.0 | Yes | Ramp Slope (%) | 6.6 |
| No | Ramp Width (in) | 46.5 | Yes | Ramp XSlope (%) | 2.0 |

**Remove & Replace Curb Ramp With Two New Directional Ramps or Equivalent.**

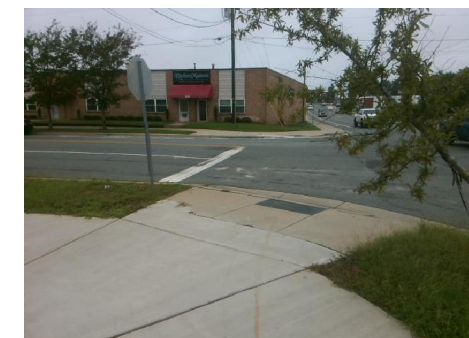
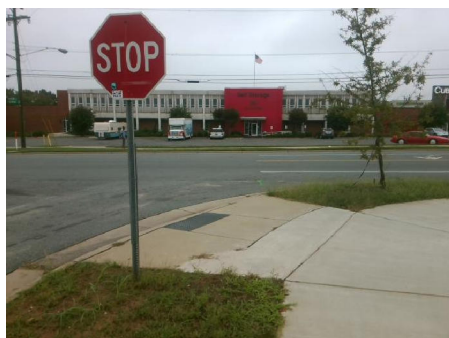
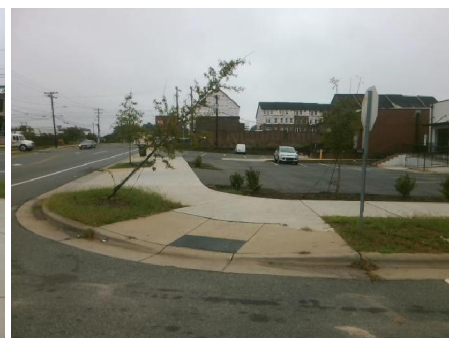
Street 1 Name CLANTON RD  
 Stop Condition-Street 2 None  
 Street 2 Name DEWITT LN  
 Stop Condition-Street 1 StopSign
