Access Compliance Report

Public Rights-of-Way

(Curb Ramps)

Intersection ID: 14177	Main Street: BARCLIFF_DR	Cross Street: TWO_MOONS_DR	Location: SE
ADA ID: E18CE7E8DED6	Ramp Type: Directional1	Initial Pass/Fail: Fail	Overall Compliance: No
Severity Score: 12.5			
Codes/Mitigation Info/Possible Solution		Field Measurements/Component Compliance

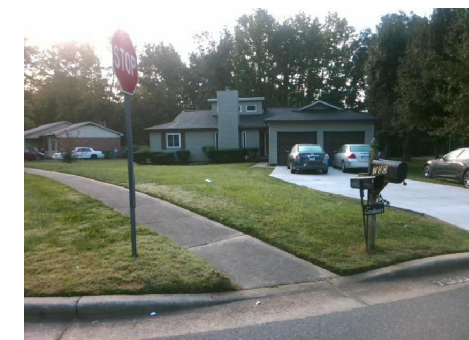
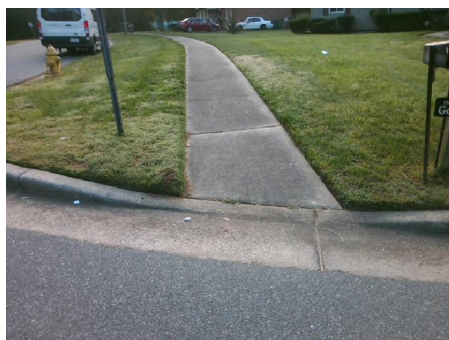
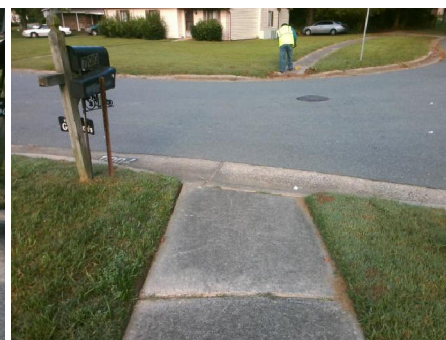
Compliance	Description	Data	Compliance	Description	Data
N/A	Ramp Length (in)	59.3	N/A	Grade Break?	N/A
Yes	Ramp Width (in)	48.0	N/A	Grade Break Slope (%)	0.0
No	Ramp Slope (%)	10.1	N/A	Grade Break XSlope (%)	0.0
Yes	Ramp XSlope (%)	1.2			
N/A	Flare Type LT	N/A	N/A	Flare Type RT	N/A
N/A	Flare Slope LT (%)	N/A	N/A	Flare Slope RT (%)	0.0
N/A	Flare Traversable LT?	N/A	N/A	Flare Traversable RT?	N/A
N/A	Landing Length (in)	0.0	N/A	DWS Provided?	N/A
N/A	Landing Width (in)	0.0	N/A	DWS Contrast?	N/A
N/A	Landing Slope (%)	0.0	N/A	DWS Length (in)	N/A
N/A	Landing X Slope (%)	0.0	N/A	DWS Full Width?	N/A
N/A	Landing Curb? (Y/N)	N/A	N/A	DWS Offset LT (in)	N/A
N/A	Shared Landing?	N/A	N/A	DWS Offset RT (in)	N/A
N/A	Gutter Ponding?	0.0	N/A	Gutter Slope (%)	N/A
N/A	Gutter Lip Ht (in)	0.0	N/A	Gutter X Slope (%)	N/A
N/A	Painted X Walk1?	No		Road Slope (%)	1.5
	X Walk 1 Direction	To W		Road X Slope (%)	2.5
	X Walk 1 Width (in)	N/A		Clear Space?	N/A

X Walk 1 Slope (%)	1.5	N/A	Clear Space to XWalk (in)	N/A
	X Walk 1 X Slope (%)	2.5	N/A	Storm Grate/Utility Hazard?	N/A
N/A	Ramp inside XWalk1?	N/A		Storm Grate/Utility Type	
N/A	Any Obstructions?	N/A			N/A
	Obstruction Type		Yes	Surface Condition? (G/P)	Good
			N/A	Curb Slope (%)	17.3

Remove & Replace Entire Ramp.
