Access Compliance Report Public Rights-of-Way (Curb Ramps)

Intersection ID: 44955 Main Street: OAKTON_HUNT_DR Cross Street: WEAVERS_GLENN_PL Location: SW

ADA ID: E18D8BDE708F Ramp Type: PerpDiag Initial Pass/Fail: Fail Overall Compliance: No Severity Score: 8.75

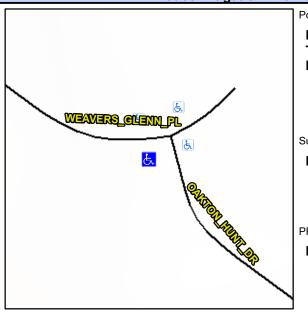
Not Found, R304.5.1

i ieiu ivieasui e	mema/c	onipo	nent compnance		
Compliance Description		Data	Compliance Description		Data	
N/A	Ramp Length (in)	50.0	Yes	Ramp Slope (%)	5.0	
No	Ramp Width (in)	45.0	Yes	Ramp XSlope (%)	0.8	
N/A	Flare Type LT	N/A	N/A	Flare Type RT	N/A	
N/A	Flare Slope LT (%)	N/A	N/A	Flare Slope RT (%)	N/A	
N/A	Flare Traversable LT?	N/A	N/A	Flare Traversable RT?	N/A	
N/A	Landing Length (in)	N/A	N/A	DWS Provided?	N/A	
N/A	Landing Width (in)	N/A	N/A	DWS Contrast?	N/A	
N/A	Landing Slope (%)	N/A	N/A	DWS Length (in)	N/A	
N/A	Landing X Slope (%)	N/A	N/A	DWS Full Width?	N/A	
N/A	Landing Curb? (Y/N)	N/A	N/A	DWS Offset (in)	N/A	
N/A	Shared Landing?	N/A				
N/A	Gutter Ponding?	N/A	N/A	Gutter Slope (%)	N/A	
N/A	Gutter Lip Ht (in)	N/A	N/A	Gutter X Slope (%)	N/A	
N/A	Painted X Walk1?	No	N/A	Painted X Walk2?	No	
	X Walk 1 Direction	To E		X Walk 2 Direction	To N	
N/A	X Walk 1 Width (in)	N/A	N/A	X Walk 2 Width (in)	N/A	
	X Walk 1 Slope (%)	6.5		X Walk 2 Slope (%)	4.0

X Walk 1 X Slope (%)	1.4		X Walk 2 X Slope (%)	2.8	
N/A	Ramp inside XWalk1?	N/A	N/A	Ramp inside XWalk2?	N/A	
	Road Slope (%)	0.6	N/A	Clear Space?	N/A	
	Road X Slope (%)	4.2	N/A	Clear Space to XWalk (in)	N/A	
N/A	Any Obstructions?	N/A	N/A	Storm Grate/Utility Hazard?	N/A	
	Obstruction Type			Storm Grate/Utility Type		
		N/A			N/A

Remove & Replace Curb Ramp With Two New Directional Ramps or Equivalent.

Total Cost: \$ 3200.00
