# Access Compliance Report

## Public Rights-of-Way

### (Curb Ramps)

Intersection ID: 46916	Main Street: SHORTLEAF_PINE_CT	Cross Street: PONDEROSA_PINE_LN	Location: S
ADA ID: E18E77A424AE	Ramp Type: PerpDiag	Initial Pass/Fail: Fail	Overall Compliance: No
Severity Score: 22.5			
Codes/Mitigation Info/Possible Solution		Field Measurements/Component Compliance

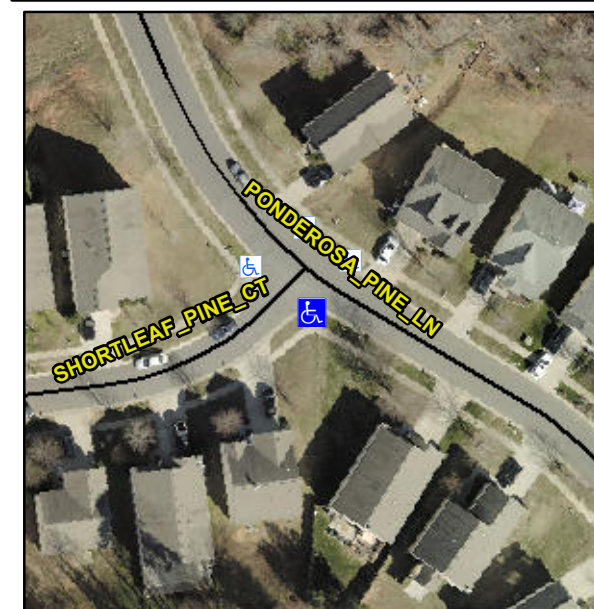
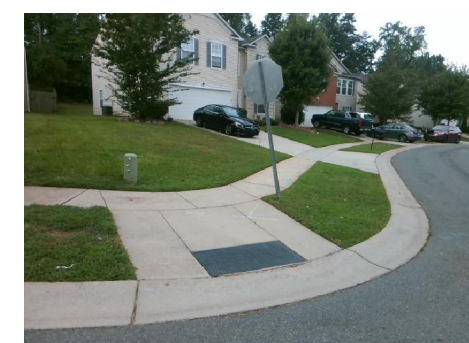
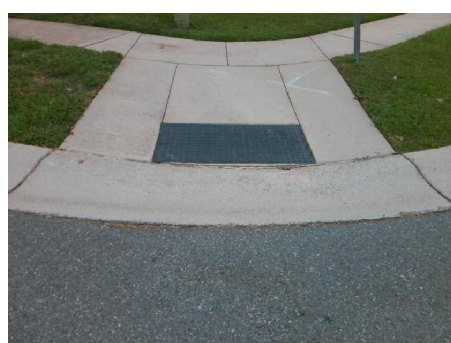
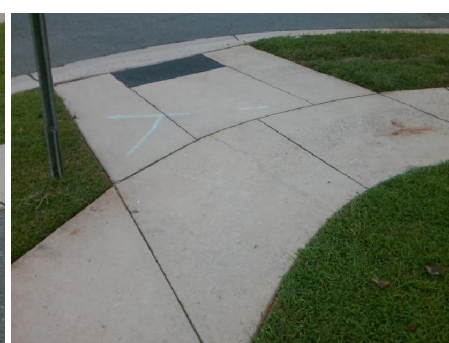
**Not Found, R304.5.1, R304.2.2, R304.5.3**

Compliance	Description	Data	Compliance	Description	Data
N/A	Ramp Length (in)	86.0	No	Ramp Slope (%)	8.8
No	Ramp Width (in)	47.5	No	Ramp XSlope (%)	2.6
N/A	Flare Type LT	N/A	N/A	Flare Type RT	N/A
N/A	Flare Slope LT (%)	N/A	N/A	Flare Slope RT (%)	N/A
N/A	Flare Traversable LT?	N/A	N/A	Flare Traversable RT?	N/A
N/A	Landing Length (in)	N/A	N/A	DWS Provided?	N/A
N/A	Landing Width (in)	N/A	N/A	DWS Contrast?	N/A
N/A	Landing Slope (%)	N/A	N/A	DWS Length (in)	N/A
N/A	Landing X Slope (%)	N/A	N/A	DWS Full Width?	N/A
N/A	Landing Curb? (Y/N)	N/A	N/A	DWS Offset (in)	N/A
N/A	Shared Landing?	N/A			
N/A	Gutter Ponding?	N/A	N/A	Gutter Slope (%)	N/A
N/A	Gutter Lip Ht (in)	N/A	N/A	Gutter X Slope (%)	N/A
N/A	Painted X Walk1?	No	N/A	Painted X Walk2?	No
	X Walk 1 Direction	To NE		X Walk 2 Direction	To NW
N/A	X Walk 1 Width (in)	N/A	N/A	X Walk 2 Width (in)	N/A
	X Walk 1 Slope (%)	0.9		X Walk 2 Slope (%)	3.3
	X Walk 1 X Slope (%)	3.7		X Walk 2 X Slope (%)	1.7

N/A	Ramp inside XWalk1?	N/A	N/A	Ramp inside XWalk2?	N/A
	Road Slope (%)	4.8	N/A	Clear Space?	N/A
	Road X Slope (%)	1.0	N/A	Clear Space to XWalk (in)	N/A
N/A	Any Obstructions?	N/A	N/A	Storm Grate/Utility Hazard?	N/A
	Obstruction Type			Storm Grate/Utility Type	
		N/A			N/A
			Yes	Surface Condition? (G/P)	Good

**Remove & Replace Curb Ramp With Two New Directional Ramps or Equivalent.**
