# Access Compliance Report

## Public Rights-of-Way

### (Curb Ramps)

Intersection ID: 10035003	Main Street: PROVIDENCE_RD	Cross Street: N/A	Location: NE
ADA ID: E196F88B7D64	Ramp Type: Combination1Diag	Initial Pass/Fail: Fail	Overall Compliance: No
		Severity Score: 0

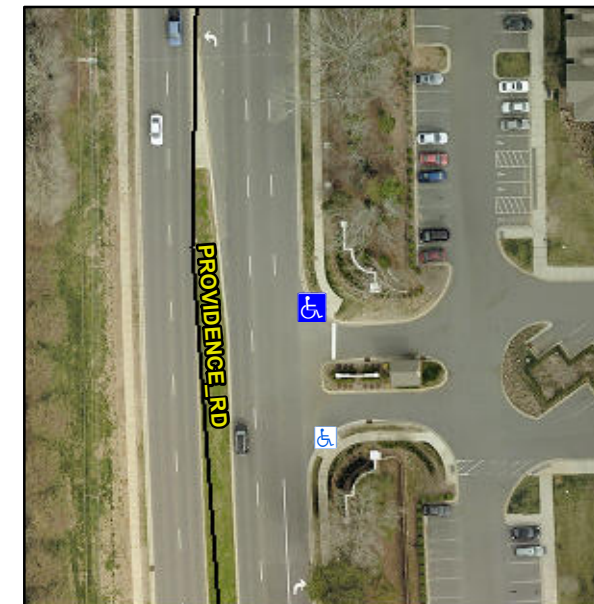
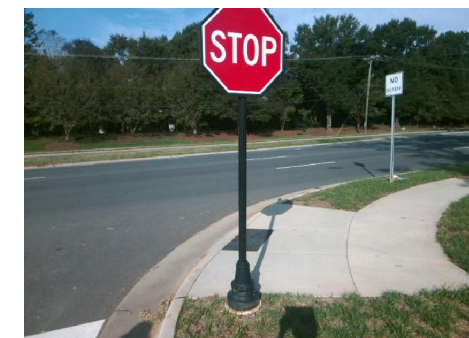
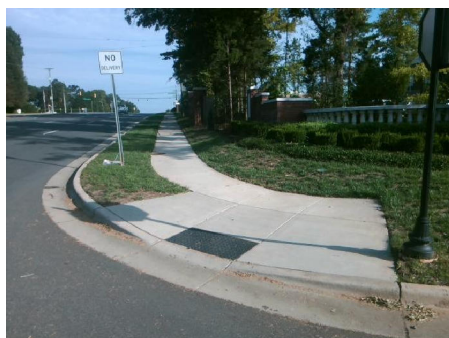
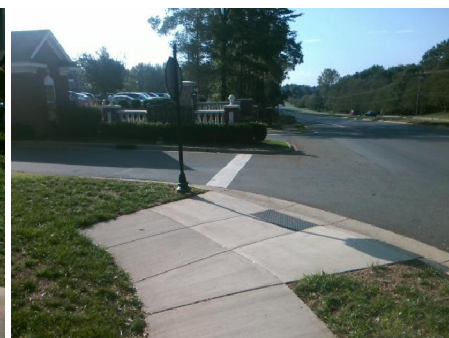
**RT RP < 5%**

**Not Found, R304.5.1, R304.2.2, R304.5.3, R304.3.2**

Compliance	Description	Data	Compliance	Description	Data
N/A	Ramp Length LT (in)	34.0	N/A	Ramp Length RT (in)	41.0
Yes	Ramp Width LT (in)	58.0	Yes	Ramp Width RT (in)	54.0
No	Ramp Slope LT (%)	9.3	Yes	Ramp Slope RT (%)	0.8
Yes	Ramp XSlope LT (%)	0.9	No	Ramp XSlope RT (%)	2.1
N/A	Ramp Length (in)	77.0	No	Ramp Slope (%)	9.5
No	Ramp Width (in)	47.0	No	Ramp XSlope (%)	3.8
N/A	Flare Type LT	N/A	N/A	Flare Type RT	N/A
N/A	Flare Slope LT (%)	N/A	N/A	Flare Slope RT (%)	N/A
N/A	Flare Traversable LT?	N/A	N/A	Flare Traversable RT?	N/A
N/A	Landing Length (in)	N/A	N/A	DWS Provided?	N/A
N/A	Landing Width (in)	N/A	N/A	DWS Contrast?	N/A
N/A	Landing Slope (%)	N/A	N/A	DWS Length (in)	N/A
N/A	Landing X Slope (%)	N/A	N/A	DWS Full Width?	N/A
N/A	Landing Curb? (Y/N)	N/A	N/A	DWS Offset (in)	N/A
N/A	Shared Landing?	N/A			
N/A	Gutter Ponding?	N/A	N/A	Gutter Slope (%)	N/A
N/A	Gutter Lip Ht (in)	N/A	N/A	Gutter X Slope (%)	N/A
N/A	Painted X Walk1?	No	N/A	Painted X Walk2?	No

**Remove & Replace Curb Ramp With Two New Directional Ramps or Equivalent.**
