Access Compliance Report

Public Rights-of-Way

(Curb Ramps)

Intersection ID: 50998	Main Street: S_TRYON_ST	Cross Street: STEELECROFT_PY	Location: SE
ADA ID: E1A3C46FB7BE	Ramp Type: Perp	Initial Pass/Fail: Fail	Overall Compliance: No
Severity Score: 12.5			
Codes/Mitigation Info/Possible Solution		Field Measurements/Component Compliance

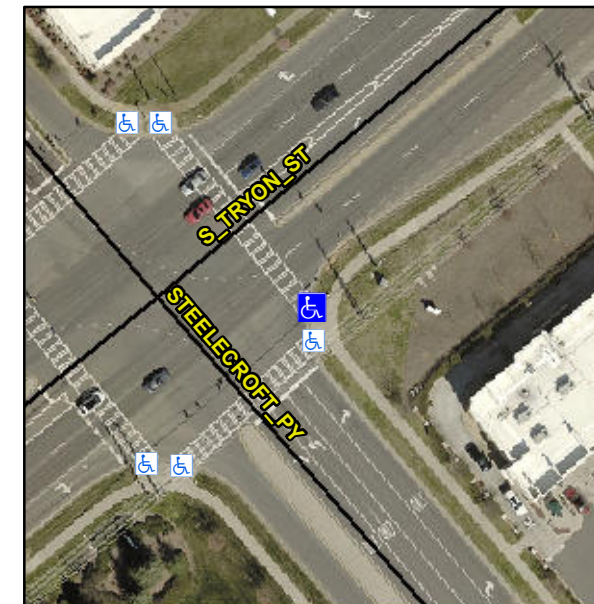
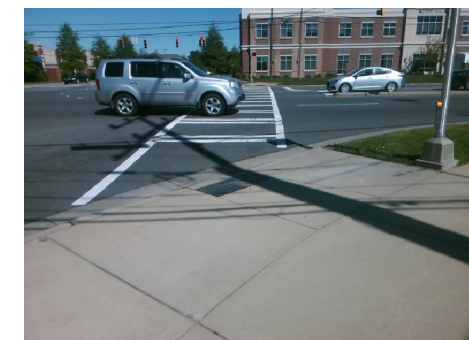
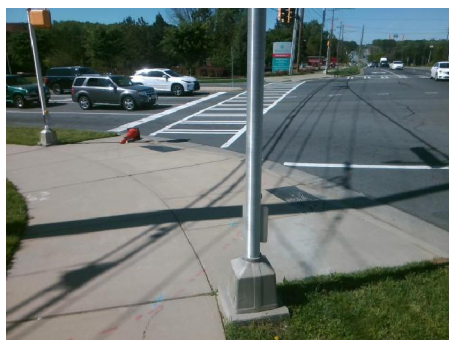
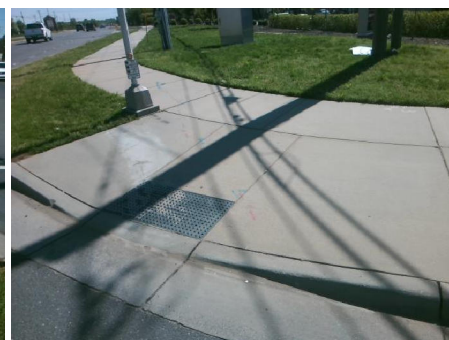
Not Found, R304.5.3

Compliance	Description	Data	Compliance	Description	Data
N/A	Ramp Length (in)	96.0	Yes	Ramp Slope (%)	6.8
Yes	Ramp Width (in)	48.0	No	Ramp XSlope (%)	6.6
N/A	Flare Type LT	N/A	N/A	Flare Type RT	N/A
N/A	Flare Slope LT (%)	N/A	N/A	Flare Slope RT (%)	N/A
N/A	Flare Traversable LT?	N/A	N/A	Flare Traversable RT?	N/A
N/A	Landing Length (in)	N/A	N/A	DWS Provided?	N/A
N/A	Landing Width (in)	N/A	N/A	DWS Contrast?	N/A
N/A	Landing Slope (%)	N/A	N/A	DWS Length (in)	N/A
N/A	Landing X Slope (%)	N/A	N/A	DWS Full Width?	N/A
N/A	Landing Curb? (Y/N)	N/A	N/A	DWS Offset (in)	N/A
N/A	Shared Landing?	N/A			
N/A	Gutter Ponding?	N/A	N/A	Gutter Slope (%)	N/A
N/A	Gutter Lip Ht (in)	N/A	N/A	Gutter X Slope (%)	N/A
N/A	Painted X Walk1?	Yes	N/A	Painted X Walk2?	N/A
	X Walk 1 Direction	To NW		X Walk 2 Direction	N/A
N/A	X Walk 1 Width (in)	111.0	N/A	X Walk 2 Width (in)	N/A
	X Walk 1 Slope (%)	8.4		X Walk 2 Slope (%)	N/A
	X Walk 1 X Slope (%)	1.7		X Walk 2 X Slope (%)	N/A

N/A	Ramp inside XWalk1?	Yes	N/A	Ramp inside XWalk2?	N/A
	Road Slope (%)	N/A	N/A	Clear Space?	N/A
	Road X Slope (%)	N/A	N/A	Clear Space to XWalk (in)	N/A
N/A	Any Obstructions?	N/A	N/A	Storm Grate/Utility Hazard?	N/A
	Obstruction Type			Storm Grate/Utility Type	
		N/A			N/A
			Yes	Surface Condition? (G/P)	Good

Remove & Replace Entire Ramp.

Total Cost: \$ 1850.00
