Access Compliance Report

Public Rights-of-Way

(Curb Ramps)

Intersection ID: 31585	Main Street: NAPTON_CT	Cross Street: PATTONSBURG_DR	Location: SE
ADA ID: E1B00CB9DDAA	Ramp Type: BlendTrans1	Initial Pass/Fail: Fail	Overall Compliance: No
Severity Score: 10			
Codes/Mitigation Info/Possible Solution		Field Measurements/Component Compliance

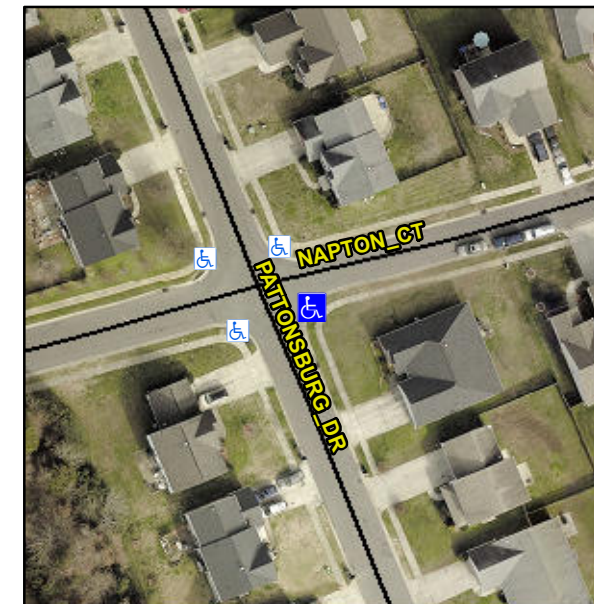
Compliance	Description	Data	Compliance	Description	Data
N/A	Ramp Length (in)	52.0	Yes	BlendTrans Slope (%)	3.2
No	Ramp Width (in)	40.0	No	BlendTrans XSlope (%)	2.2
N/A	Flare Type LT	N/A	N/A	Flare Type RT	N/A
N/A	Flare Slope LT (%)	N/A	N/A	Flare Slope RT (%)	N/A
N/A	Flare Traversable LT?	N/A	N/A	Flare Traversable RT?	N/A
N/A	Landing Length (in)	N/A	N/A	DWS Provided?	N/A
N/A	Landing Width (in)	N/A	N/A	DWS Contrast?	N/A
N/A	Landing Slope (%)	N/A	N/A	DWS Length (in)	N/A
N/A	Landing X Slope (%)	N/A	N/A	DWS Full Width?	N/A
N/A	Landing Curb? (Y/N)	N/A	N/A	DWS Offset (in)	N/A
N/A	Shared Landing?	N/A			
N/A	Gutter Ponding?	N/A	N/A	Gutter Slope (%)	N/A
N/A	Gutter Lip Ht (in)	0.5	N/A	Gutter X Slope (%)	N/A
N/A	Painted X Walk1?	No	N/A	Painted X Walk2?	No
	X Walk 1 Direction	To N		X Walk 2 Direction	To W
	X Walk 1 Width (in)	N/A		X Walk 2 Width (in)	N/A
	X Walk 1 Slope (%)	3.3		X Walk 2 Slope (%)	0.8
	X Walk 1 X Slope (%)	0.7		X Walk 2 X Slope (%)	3.0

N/A	Ramp inside XWalk1?	N/A	N/A	Ramp inside XWalk2?	N/A
	Road Slope (%)	1.4		Clear Space?	N/A
	Road X Slope (%)	2.6	N/A	Clear Space to XWalk (in)	N/A
N/A	Any Obstructions?	N/A	N/A	Storm Grate/Utility Hazard?	N/A
	Obstruction Type			Storm Grate/Utility Type	
		N/A			N/A
			Yes	Surface Condition? (G/P)	Good
			No	Curb Slope (%)	15.8

Possible Solutions:

Remove & Replace Curb Ramp With Two New Directional Ramps or Equivalent.
