Access Compliance Report

Public Rights-of-Way

(Curb Ramps)

Intersection ID: 18847	Main Street: BRACE_RD	Cross Street: RAMA_RD	Location: W
ADA ID: E1B6544A11FD	Ramp Type: PerpDiag	Initial Pass/Fail: Fail	Overall Compliance: No
		Severity Score: 37.5

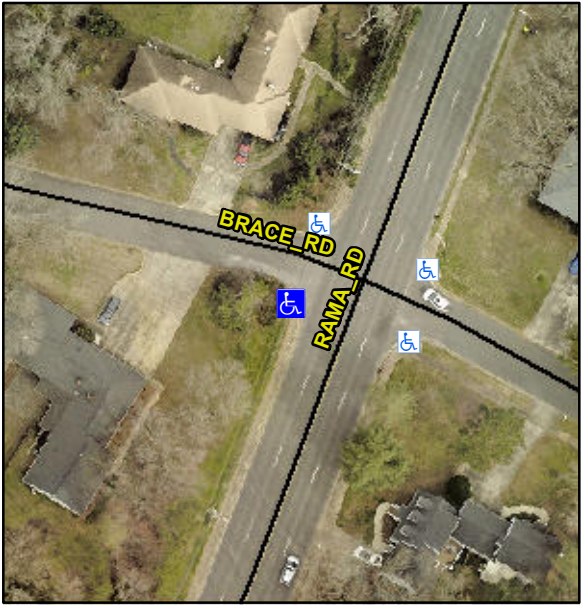
Possible Solutions:		Compliance	Description	Data
	Remove & Replace Curb Ramp With Two New Directional Ramps or Equivalent.		No	Ramp Length (in)	56.0
			Yes	Ramp Width (in)	48.0
			N/A	Flare Type LT	N/A
			N/A	Flare Slope LT (%)	N/A
			N/A	Flare Traversable LT?	N/A
			N/A	Landing Length (in)	N/A
			N/A	Landing Width (in)	N/A
			N/A	Landing Slope (%)	N/A
			N/A	Landing X Slope (%)	N/A
<p>Surveyor Notes:</p> <p>N/A</p> <p>PROW/ADA:</p> <p>Not Found, R304.2.2, R304.5.3</p>			N/A	Flare Type RT	N/A
			N/A	Flare Slope RT (%)	N/A
			N/A	Flare Traversable RT?	N/A
			N/A	DWS Provided?	N/A
			N/A	DWS Contrast?	N/A
			N/A	DWS Length (in)	N/A
			N/A	DWS Full Width?	N/A
			N/A	DWS Offset (in)	N/A
			N/A	Gutter Ponding?	N/A
			N/A	Gutter Lip Ht (in)	N/A
<p>Total Cost:</p> <p>\$ 3200.00</p>			No	Painted X Walk2?	No
			To SE	X Walk 2 Direction	To NE
