# Access Compliance Report

## Public Rights-of-Way

### (Curb Ramps)

Intersection ID: 30436	Main Street: MARIANNES RIDGE RD	Cross Street: STEELE MEADOW RD	Location: SW
ADA ID: E1B8259817C1	Ramp Type: PerpDiag	Initial Pass/Fail: Fail	Overall Compliance: No
Severity Score: 12.5			
Codes/Mitigation Info/Possible Solution		Field Measurements/Component Compliance

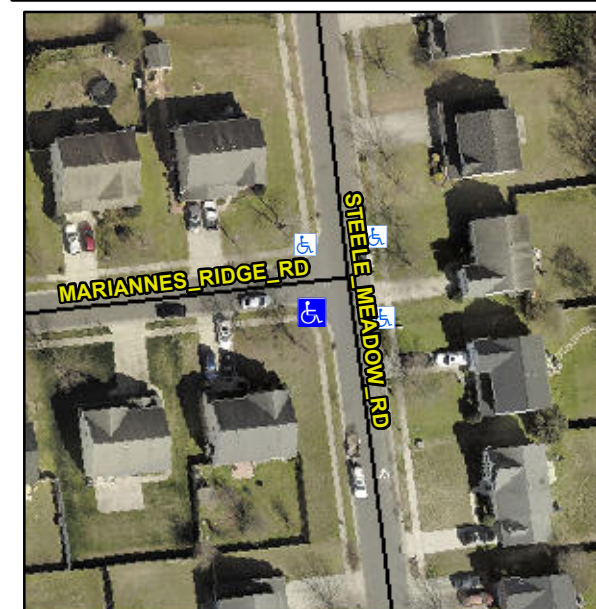
Compliance	Description	Data	Compliance	Description	Data
N/A	Ramp Length (in)	48.0	No	Ramp Slope (%)	8.7
Yes	Ramp Width (in)	48.0	Yes	Ramp XSlope (%)	0.5
N/A	Flare Type LT	N/A	N/A	Flare Type RT	N/A
N/A	Flare Slope LT (%)	N/A	N/A	Flare Slope RT (%)	N/A
N/A	Flare Traversable LT?	N/A	N/A	Flare Traversable RT?	N/A
N/A	Landing Length (in)	N/A	N/A	DWS Provided?	N/A
N/A	Landing Width (in)	N/A	N/A	DWS Contrast?	N/A
N/A	Landing Slope (%)	N/A	N/A	DWS Length (in)	N/A
N/A	Landing X Slope (%)	N/A	N/A	DWS Full Width?	N/A
N/A	Landing Curb? (Y/N)	N/A	N/A	DWS Offset (in)	N/A
N/A	Shared Landing?	N/A			
N/A	Gutter Ponding?	N/A	N/A	Gutter Slope (%)	N/A
N/A	Gutter Lip Ht (in)	N/A	N/A	Gutter X Slope (%)	N/A
N/A	Painted X Walk1?	No	N/A	Painted X Walk2?	No
	X Walk 1 Direction	To E		X Walk 2 Direction	To N
N/A	X Walk 1 Width (in)	N/A	N/A	X Walk 2 Width (in)	N/A
	X Walk 1 Slope (%)	2.3		X Walk 2 Slope (%)	2.0
	X Walk 1 X Slope (%)	0.5		X Walk 2 X Slope (%)	1.1

N/A	Ramp inside XWalk1?	N/A	N/A	Ramp inside XWalk2?	N/A
	Road Slope (%)	0.3	N/A	Clear Space?	N/A
	Road X Slope (%)	3.9	N/A	Clear Space to XWalk (in)	N/A
N/A	Any Obstructions?	N/A	N/A	Storm Grate/Utility Hazard?	N/A
	Obstruction Type			Storm Grate/Utility Type	
		N/A			N/A
			Yes	Surface Condition? (G/P)	Good

Possible Solutions:

**Remove & Replace Curb Ramp With Two New Directional Ramps or Equivalent.**

**R304.2.2**

Total Cost: \$ 3200.00
