# Access Compliance Report

## Public Rights-of-Way

### (Curb Ramps)

| Intersection ID: N/A | Main Street: CANTERBURY_CASTLE_DR | Cross Street: BELVEDERE_CASTLE_DR | Location: E |

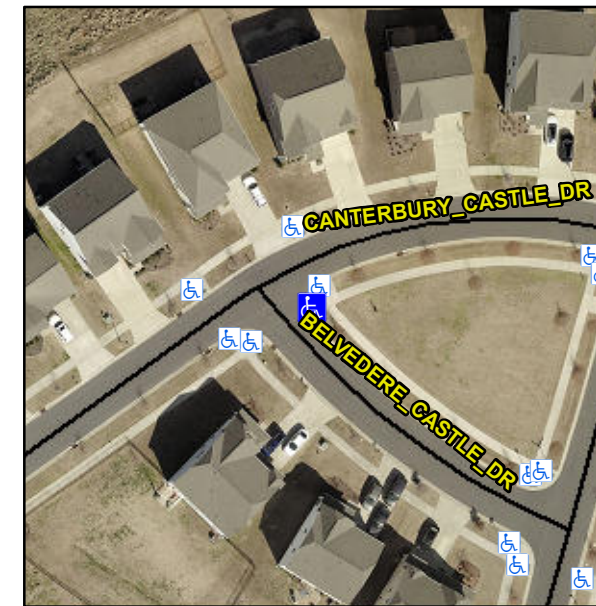
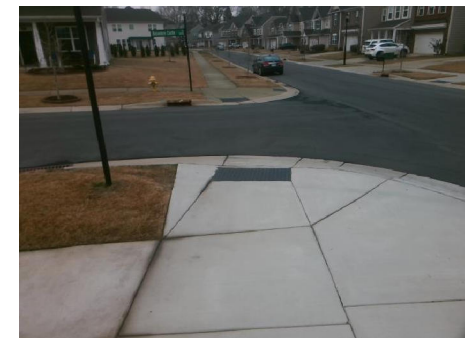
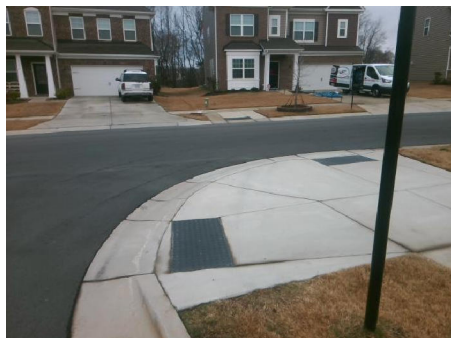
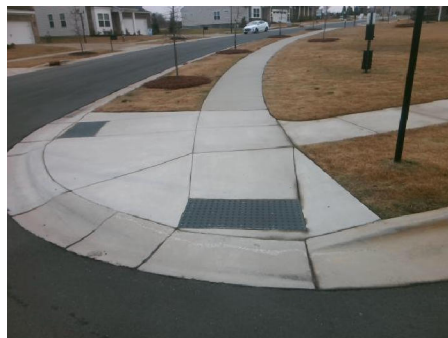
| ADA ID: E1C1A0E5288A | Ramp Type: BlendTrans1 | Initial Pass/Fail: Fail | Overall Compliance: No |
| Severity Score: 8.75 | | | |

**R304.5.1**

| Compliance | Description | Data | Compliance | Description | Data |
|---|---|---|---|---|---|
| No | Ramp Width (in) | 46.5 | Yes | BlendTrans XSlope (%) | 1.6 |

**Remove & Replace Curb Ramp With Two New Directional Ramps or Equivalent.**

Total Cost: \$ 3200.00
