Access Compliance Report

Public Rights-of-Way (Curb Ramps)

Intersection ID: 13314	Main Street: BALGREEN_CT	Cross Street: BIEDERBECK_DR	Location:	E
ADA ID: E1CD18062593	Ramp Type: PerpDiag	Initial Pass/Fail: Fail	Overall Compliance: No	Severity Score: 22.5
Codes/Mitigation Info/Possible Solution		Field Measurements/Component Compliance

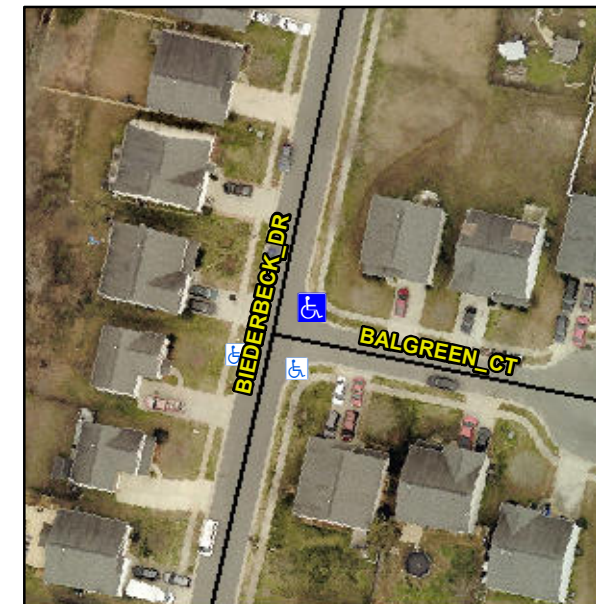
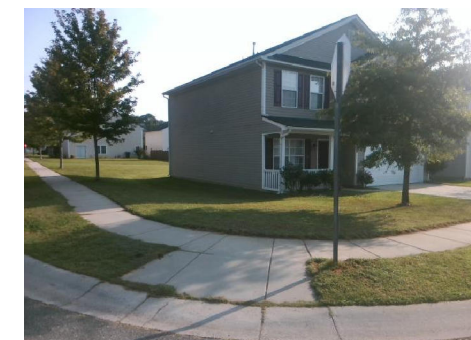
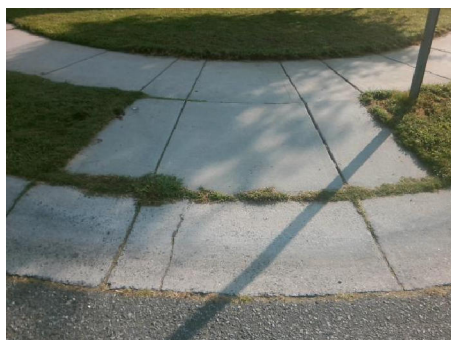
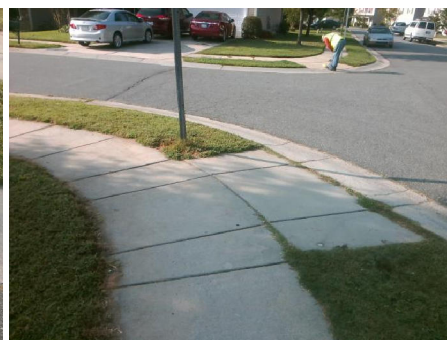
Not Found, R304.5.1, R304.2.2, R304.5.3

Compliance	Description	Data	Compliance	Description	Data
N/A	Ramp Length (in)	48.0	No	Ramp Slope (%)	10.2
No	Ramp Width (in)	40.0	No	Ramp XSlope (%)	4.0
N/A	Flare Type LT	N/A	N/A	Flare Type RT	N/A
N/A	Flare Slope LT (%)	N/A	N/A	Flare Slope RT (%)	N/A
N/A	Flare Traversable LT?	N/A	N/A	Flare Traversable RT?	N/A
N/A	Landing Length (in)	N/A	N/A	DWS Provided?	N/A
N/A	Landing Width (in)	N/A	N/A	DWS Contrast?	N/A
N/A	Landing Slope (%)	N/A	N/A	DWS Length (in)	N/A
N/A	Landing X Slope (%)	N/A	N/A	DWS Full Width?	N/A
N/A	Landing Curb? (Y/N)	N/A	N/A	DWS Offset (in)	N/A
N/A	Shared Landing?	N/A			
N/A	Gutter Ponding?	N/A	N/A	Gutter Slope (%)	N/A
N/A	Gutter Lip Ht (in)	N/A	N/A	Gutter X Slope (%)	N/A
N/A	Painted X Walk1?	No	N/A	Painted X Walk2?	No
	X Walk 1 Direction	To NW		X Walk 2 Direction	To SW
N/A	X Walk 1 Width (in)	N/A	N/A	X Walk 2 Width (in)	N/A
	X Walk 1 Slope (%)	5.2		X Walk 2 Slope (%)	0.5
	X Walk 1 X Slope (%)	1.3		X Walk 2 X Slope (%)	1.2

N/A	Ramp inside XWalk1?	N/A	N/A	Ramp inside XWalk2?	N/A
	Road Slope (%)	1.8	N/A	Clear Space?	N/A
	Road X Slope (%)	4.8	N/A	Clear Space to XWalk (in)	N/A
N/A	Any Obstructions?	N/A	N/A	Storm Grate/Utility Hazard?	N/A
	Obstruction Type			Storm Grate/Utility Type	
		N/A			N/A
			Yes	Surface Condition? (G/P)	Good

Remove & Replace Curb Ramp With Two New Directional Ramps or Equivalent.
