Access Compliance Report

Public Rights-of-Way

(Curb Ramps)

Intersection ID: 10020377	Main Street: BALLANTYNE CORPORATE PL	Cross Street: N/A	Location: SW
ADA ID: E1D5ABC2CE11	Ramp Type: Perp	Initial Pass/Fail: Fail	Overall Compliance: No
Severity Score: 37.5			
Codes/Mitigation Info/Possible Solution		Field Measurements/Component Compliance

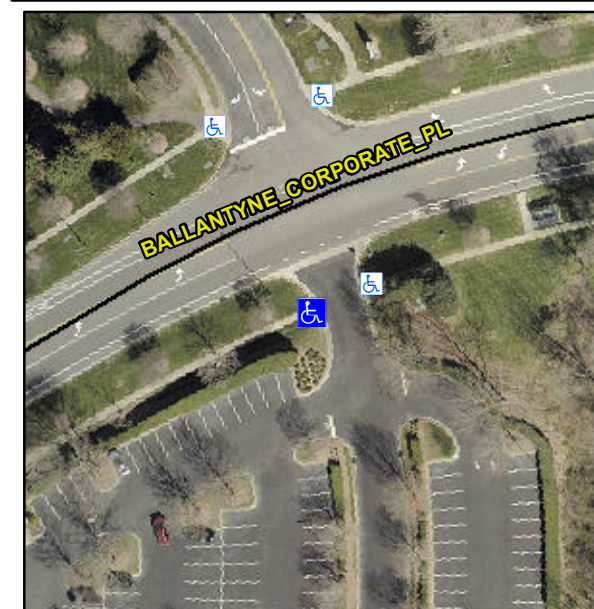
Compliance	Description	Data	Compliance	Description	Data
N/A	Ramp Length (in)	60.0	No	Ramp Slope (%)	9.3
Yes	Ramp Width (in)	48.0	No	Ramp XSlope (%)	10.4
N/A	Flare Type LT	N/A	N/A	Flare Type RT	N/A
N/A	Flare Slope LT (%)	N/A	N/A	Flare Slope RT (%)	N/A
N/A	Flare Traversable LT?	N/A	N/A	Flare Traversable RT?	N/A
N/A	Landing Length (in)	N/A	N/A	DWS Provided?	N/A
N/A	Landing Width (in)	N/A	N/A	DWS Contrast?	N/A
N/A	Landing Slope (%)	N/A	N/A	DWS Length (in)	N/A
N/A	Landing X Slope (%)	N/A	N/A	DWS Full Width?	N/A
N/A	Landing Curb? (Y/N)	N/A	N/A	DWS Offset (in)	N/A
N/A	Shared Landing?	N/A			
N/A	Gutter Ponding?	N/A	N/A	Gutter Slope (%)	N/A
N/A	Gutter Lip Ht (in)	N/A	N/A	Gutter X Slope (%)	N/A
N/A	Painted X Walk1?	No	N/A	Painted X Walk2?	N/A
	X Walk 1 Direction	To E		X Walk 2 Direction	N/A
N/A	X Walk 1 Width (in)	N/A	N/A	X Walk 2 Width (in)	N/A
	X Walk 1 Slope (%)	4.2		X Walk 2 Slope (%)	N/A
	X Walk 1 X Slope (%)	10.6		X Walk 2 X Slope (%)	N/A

N/A	Ramp inside XWalk1?	N/A	N/A	Ramp inside XWalk2?	N/A
	Road Slope (%)	N/A	N/A	Clear Space?	N/A
	Road X Slope (%)	N/A	N/A	Clear Space to XWalk (in)	N/A
N/A	Any Obstructions?	N/A	N/A	Storm Grate/Utility Hazard?	N/A
	Obstruction Type			Storm Grate/Utility Type	
		N/A			N/A
			Yes	Surface Condition? (G/P)	Good

Possible Solutions:

Remove & Replace Entire Ramp.

R304.2.2, R304.5.3

Total Cost:

\$ 1850.00
