Access Compliance Report

Public Rights-of-Way

(Curb Ramps)

| Intersection ID: 45061 | Main Street: EVANGELION_CT | Cross Street: REDDING_GLEN_AV | Location: SW |

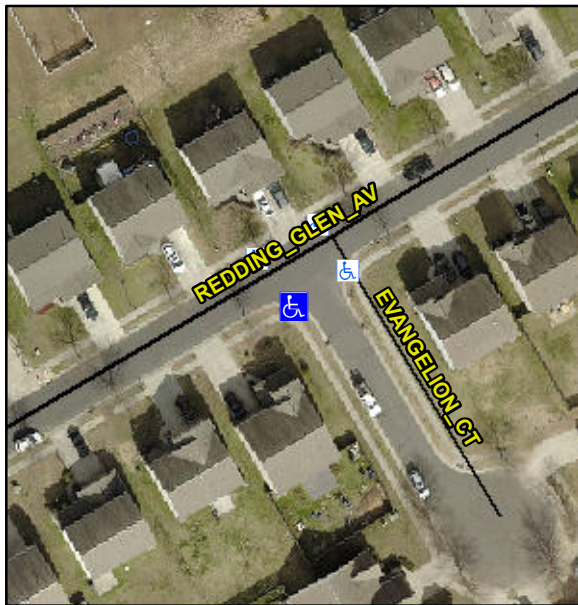
| ADA ID: E1E065FFFDCE | Ramp Type: PerpDiag | Initial Pass/Fail: Fail | Overall Compliance: No |

Not Found, R304.5.1

| Compliance | Description | Data | Compliance | Description | Data |
|---|---|---|---|---|---|
| No | Ramp Width (in) | 47.0 | Yes | Ramp XSlope (%) | 0.7 |

Remove & Replace Curb Ramp With Two New Directional Ramps or Equivalent.

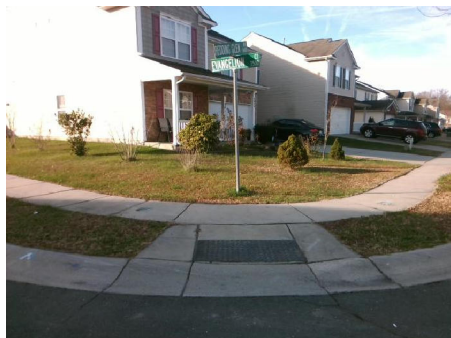
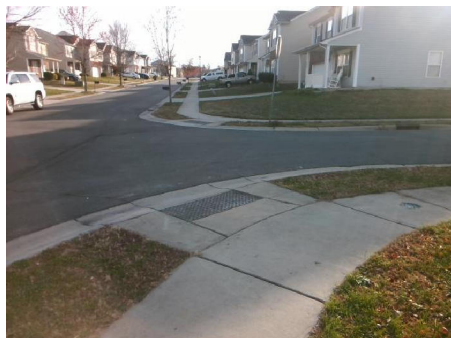
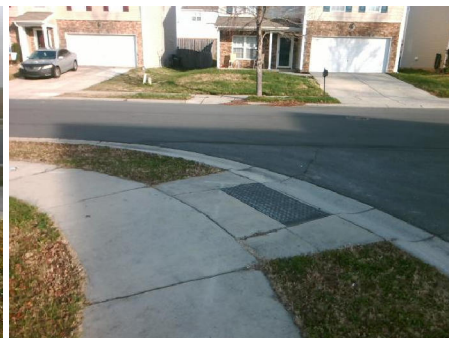
| Compliance | Description | Data | Compliance | Description | Data |
|---|---|---|---|---|---|
| N/A | Ramp Length (in) | 48.0 | Yes | Ramp Slope (%) | 6.4 |
| | | | Yes | Surface Condition? (G/P) | Good |
