Access Compliance Report

Public Rights-of-Way

(Curb Ramps)

Intersection ID: 53162	Main Street: OBAN_CT	Cross Street: HAMILTON_BRIDGE_RD	Location: SW
ADA ID: E1E07ADADD9	Ramp Type: BlendTrans1	Initial Pass/Fail: Fail	Overall Compliance: No
Severity Score: 8.75			
Codes/Mitigation Info/Possible Solution		Field Measurements/Component Compliance

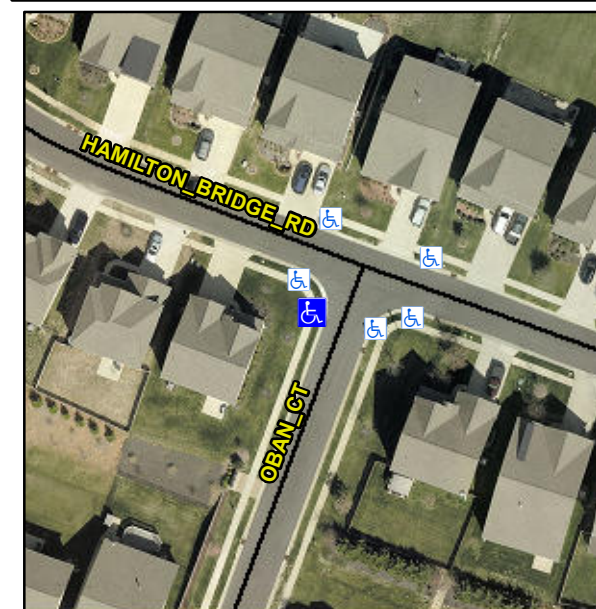
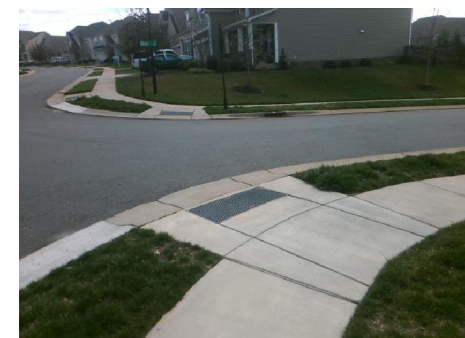
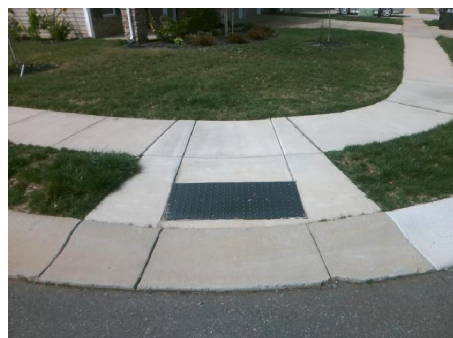
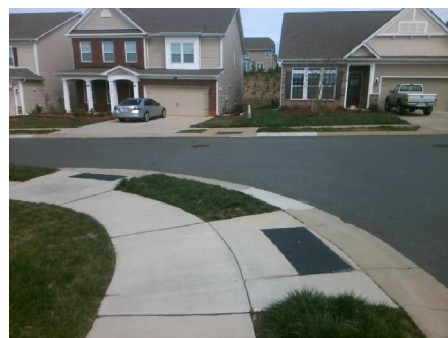
Compliance	Description	Data	Compliance	Description	Data
N/A	Ramp Length (in)	48.0	Yes	BlendTrans Slope (%)	2.1
No	Ramp Width (in)	45.5	Yes	BlendTrans XSlope (%)	0.4
N/A	Flare Type LT	N/A	N/A	Flare Type RT	N/A
N/A	Flare Slope LT (%)	N/A	N/A	Flare Slope RT (%)	N/A
N/A	Flare Traversable LT?	N/A	N/A	Flare Traversable RT?	N/A
N/A	Landing Length (in)	N/A	N/A	DWS Provided?	N/A
N/A	Landing Width (in)	N/A	N/A	DWS Contrast?	N/A
N/A	Landing Slope (%)	N/A	N/A	DWS Length (in)	N/A
N/A	Landing X Slope (%)	N/A	N/A	DWS Full Width?	N/A
N/A	Landing Curb? (Y/N)	N/A	N/A	DWS Offset (in)	N/A
N/A	Shared Landing?	N/A			
N/A	Gutter Ponding?	N/A	N/A	Gutter Slope (%)	N/A
N/A	Gutter Lip Ht (in)	1.3	N/A	Gutter X Slope (%)	N/A
N/A	Painted X Walk1?	No	N/A	Painted X Walk2?	N/A
	X Walk 1 Direction	To SE		X Walk 2 Direction	N/A
	X Walk 1 Width (in)	N/A		X Walk 2 Width (in)	N/A
	X Walk 1 Slope (%)	2.6		X Walk 2 Slope (%)	N/A
	X Walk 1 X Slope (%)	2.9		X Walk 2 X Slope (%)	N/A

N/A	Ramp inside XWalk1?	N/A	N/A	Ramp inside XWalk2?	N/A
	Road Slope (%)	2.9		Clear Space?	N/A
	Road X Slope (%)	2.6	N/A	Clear Space to XWalk (in)	N/A
N/A	Any Obstructions?	N/A	N/A	Storm Grate/Utility Hazard?	N/A
	Obstruction Type			Storm Grate/Utility Type	
		N/A			N/A
			Yes	Surface Condition? (G/P)	Good
			N/A	Curb Slope (%)	0.8

Remove & Replace Curb Ramp With Two New Directional Ramps or Equivalent.

R304.5.1

\$ 3200.00
