Access Compliance Report

Public Rights-of-Way

(Curb Ramps)

Intersection ID: 10025682	Main Street: EAST_BV	Cross Street: N/A	Location: S
ADA ID: E1E2E300F203	Ramp Type: PerpDiag	Initial Pass/Fail: Fail	Overall Compliance: No
Codes/Mitigation Info/Possible Solution		Field Measurements/Component Compliance	
Severity Score: 22.5

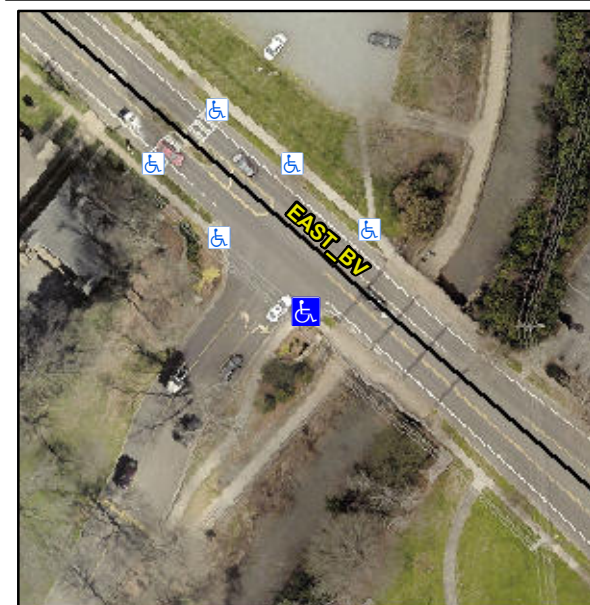
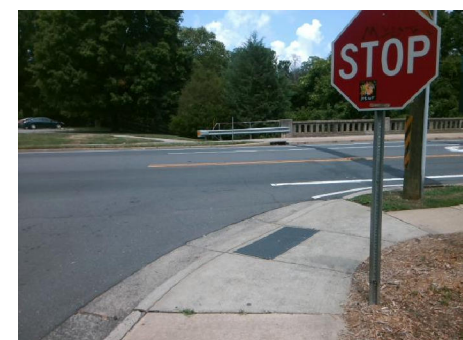
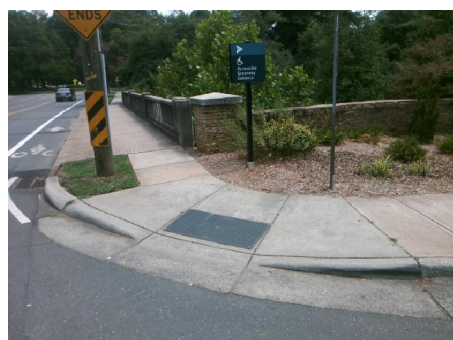
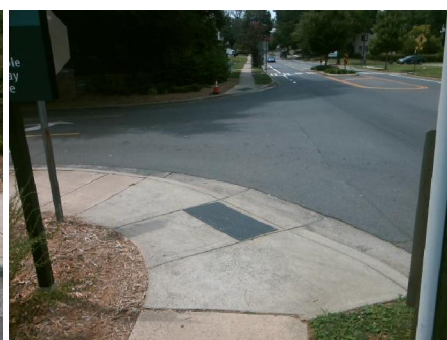
Not Found, R304.5.1, R304.2.2, R304.5.3

Compliance	Description	Data	Compliance	Description	Data
N/A	Ramp Length (in)	65.0	No	Ramp Slope (%)	9.9
No	Ramp Width (in)	42.0	No	Ramp XSlope (%)	4.9
N/A	Flare Type LT	N/A	N/A	Flare Type RT	N/A
N/A	Flare Slope LT (%)	N/A	N/A	Flare Slope RT (%)	N/A
N/A	Flare Traversable LT?	N/A	N/A	Flare Traversable RT?	N/A
N/A	Landing Length (in)	N/A	N/A	DWS Provided?	N/A
N/A	Landing Width (in)	N/A	N/A	DWS Contrast?	N/A
N/A	Landing Slope (%)	N/A	N/A	DWS Length (in)	N/A
N/A	Landing X Slope (%)	N/A	N/A	DWS Full Width?	N/A
N/A	Landing Curb? (Y/N)	N/A	N/A	DWS Offset (in)	N/A
N/A	Shared Landing?	N/A			
N/A	Gutter Ponding?	N/A	N/A	Gutter Slope (%)	N/A
N/A	Gutter Lip Ht (in)	N/A	N/A	Gutter X Slope (%)	N/A
N/A	Painted X Walk1?	No	N/A	Painted X Walk2?	No
	X Walk 1 Direction	To NE		X Walk 2 Direction	To NW
N/A	X Walk 1 Width (in)	N/A	N/A	X Walk 2 Width (in)	N/A
	X Walk 1 Slope (%)	5.5		X Walk 2 Slope (%)	2.5
	X Walk 1 X Slope (%)	1.1		X Walk 2 X Slope (%)	3.8

N/A	Ramp inside XWalk1?	N/A	N/A	Ramp inside XWalk2?	N/A
	Road Slope (%)	1.2	N/A	Clear Space?	N/A
	Road X Slope (%)	6.6	N/A	Clear Space to XWalk (in)	N/A
N/A	Any Obstructions?	N/A	N/A	Storm Grate/Utility Hazard?	N/A
	Obstruction Type			Storm Grate/Utility Type	
		N/A			N/A
			Yes	Surface Condition? (G/P)	Good

Possible Solutions:

Remove & Replace Curb Ramp With Two New Directional Ramps or Equivalent.

Total Cost: \$ **3200.00**
