Access Compliance Report

Public Rights-of-Way

(Curb Ramps)

Intersection ID: 31645	Main Street: PLAZA_WALK_DR	Cross Street: CITISIDE_DR	Location: W
ADA ID: E1EA4B362DB1	Ramp Type: PerpDiag	Initial Pass/Fail: Fail	Overall Compliance: No
Codes/Mitigation Info/Possible Solution		Field Measurements/Component Compliance	
Severity Score: 18.75

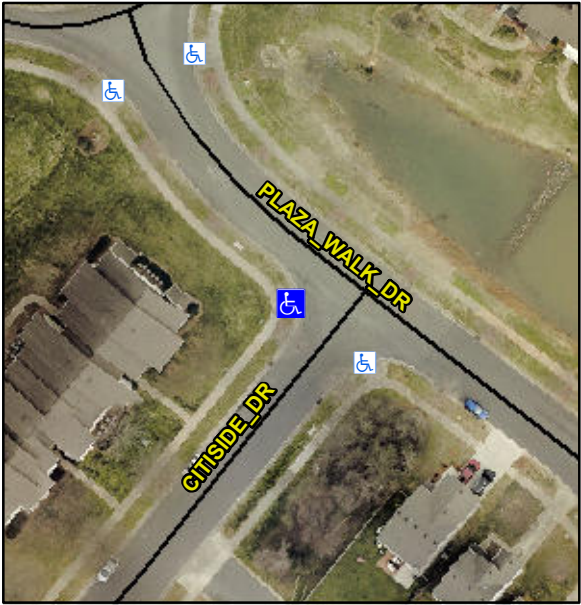
Possible Solutions:		Compliance		Description		Data	Compliance	Description	Data
	Remove & Replace Curb Ramp With Two New Directional Ramps or Equivalent.		N/A		Ramp Length (in)		94.5	Yes	Ramp Slope (%)	5.6
<p>Surveyor Notes:</p> <p>N/A</p> <p>PROW/ADA:</p> <p>Not Found, R304.5.1, R304.5.3</p>			No		Ramp Width (in)		34.5	No	Ramp XSlope (%)	3.4
			N/A		Flare Type LT		N/A	N/A	Flare Type RT	N/A
			N/A		Flare Slope LT (%)		N/A	N/A	Flare Slope RT (%)	N/A
			N/A		Flare Traversable LT?		N/A	N/A	Flare Traversable RT?	N/A
			N/A		Landing Length (in)		N/A	N/A	DWS Provided?	N/A
			N/A		Landing Width (in)		N/A	N/A	DWS Contrast?	N/A
			N/A		Landing Slope (%)		N/A	N/A	DWS Length (in)	N/A
			N/A		Landing X Slope (%)		N/A	N/A	DWS Full Width?	N/A
			N/A		Landing Curb? (Y/N)		N/A	N/A	DWS Offset (in)	N/A
			N/A		Shared Landing?		N/A			
			N/A		Gutter Ponding?		N/A	N/A	Gutter Slope (%)	N/A
			N/A		Gutter Lip Ht (in)		N/A	N/A	Gutter X Slope (%)	N/A

N/A		Painted X Walk1?		No	N/A	Painted X Walk2?	No
					X Walk 1 Direction		To SE		X Walk 2 Direction	To NE
			N/A		X Walk 1 Width (in)		N/A	N/A	X Walk 2 Width (in)	N/A
					X Walk 1 Slope (%)		3.8		X Walk 2 Slope (%)	0.7
					X Walk 1 X Slope (%)		0.4		X Walk 2 X Slope (%)	2.2
			N/A		Ramp inside XWalk1?		N/A	N/A	Ramp inside XWalk2?	N/A
					Road Slope (%)		2.2	N/A	Clear Space?	N/A
					Road X Slope (%)		0.3	N/A	Clear Space to XWalk (in)	N/A
			N/A		Any Obstructions?		N/A	N/A	Storm Grate/Utility Hazard?	N/A
					Obstruction Type				Storm Grate/Utility Type	
								N/A		N/A
								Yes	Surface Condition? (G/P)	Good
