# Access Compliance Report

## Public Rights-of-Way

### (Curb Ramps)

Intersection ID: 11958	Main Street: E_16TH_ST	Cross Street: SEIGLE_AV	Location: S
ADA ID: E1EDE08C0069	Ramp Type: Perp	Initial Pass/Fail: Fail	Overall Compliance: No
		Severity Score: 8.75

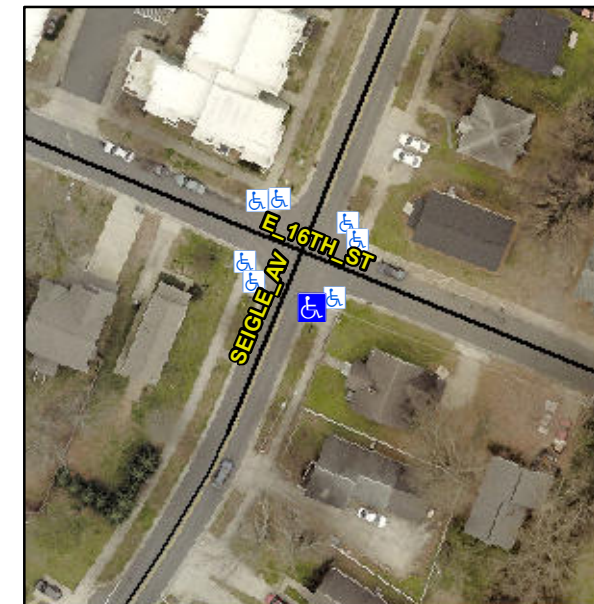
**Not Found, R304.5.1**

Compliance	Description	Data	Compliance	Description	Data
N/A	Ramp Length (in)	74.0	Yes	Ramp Slope (%)	6.3
No	Ramp Width (in)	47.5	Yes	Ramp XSlope (%)	0.9
N/A	Flare Type LT	N/A	N/A	Flare Type RT	N/A
N/A	Flare Slope LT (%)	N/A	N/A	Flare Slope RT (%)	N/A
N/A	Flare Traversable LT?	N/A	N/A	Flare Traversable RT?	N/A
N/A	Landing Length (in)	N/A	N/A	DWS Provided?	N/A
N/A	Landing Width (in)	N/A	N/A	DWS Contrast?	N/A
N/A	Landing Slope (%)	N/A	N/A	DWS Length (in)	N/A
N/A	Landing X Slope (%)	N/A	N/A	DWS Full Width?	N/A
N/A	Landing Curb? (Y/N)	N/A	N/A	DWS Offset (in)	N/A
N/A	Shared Landing?	N/A			
N/A	Gutter Ponding?	N/A	N/A	Gutter Slope (%)	N/A
N/A	Gutter Lip Ht (in)	0.5	N/A	Gutter X Slope (%)	N/A
N/A	Painted X Walk1?	No	N/A	Painted X Walk2?	N/A
	X Walk 1 Direction	To NW		X Walk 2 Direction	N/A
N/A	X Walk 1 Width (in)	N/A	N/A	X Walk 2 Width (in)	N/A
	X Walk 1 Slope (%)	0.6		X Walk 2 Slope (%)	N/A
	X Walk 1 X Slope (%)	1.2		X Walk 2 X Slope (%)	N/A

N/A	Ramp inside XWalk1?	N/A	N/A	Ramp inside XWalk2?	N/A
	Road Slope (%)	N/A	N/A	Clear Space?	N/A
	Road X Slope (%)	N/A	N/A	Clear Space to XWalk (in)	N/A
N/A	Any Obstructions?	N/A	N/A	Storm Grate/Utility Hazard?	N/A
	Obstruction Type			Storm Grate/Utility Type	
		N/A			N/A
			Yes	Surface Condition? (G/P)	Good

**Remove & Replace Entire Ramp.**

Total Cost: \$ 1850.00
